Preliminary Investigation

AUTHORS Richard Hanke, P.Eng., Project Manager and Lance Rasband, Project Manager, Malcolm Drilling Company, Inc.

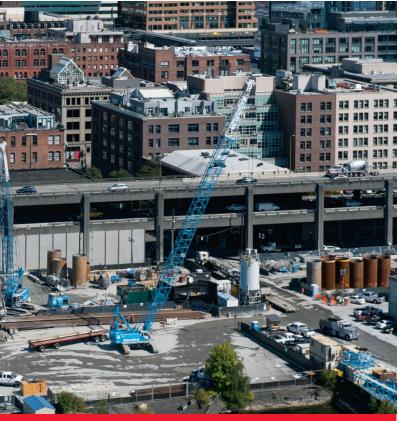
Aerial view of project site

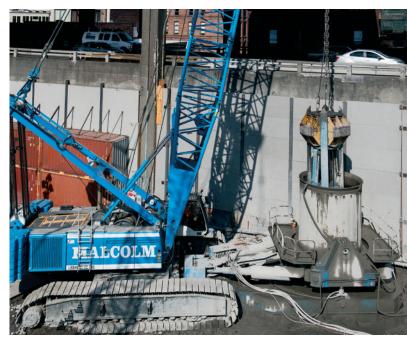
Liebherr HS 895 crane installing large diameter shafts
