CONSTRUCTION OF THE DRILLED SHAFT FOUNDATIONS FOR THE HUEY LONG MISSISSIPPI RIVER BRIDGE, NEW ORLEANS

Dan A. Brown, Ph.D., P.E., Dan Brown and Associates, Sequatchie, TN
Peter Faust, Malcolm Drilling Company, Hayward, CA
Jorge Santos, Kiewit Engineering Company, Omaha, NE

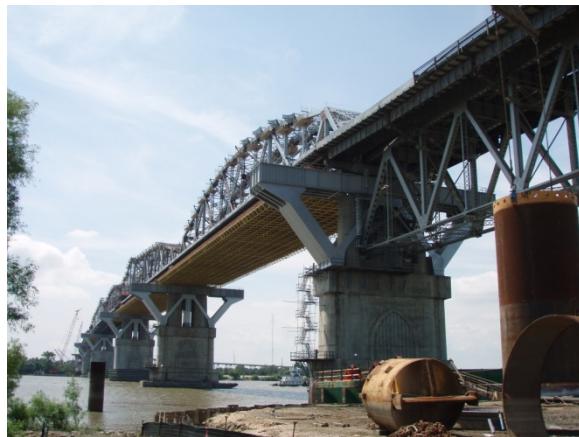
Figure 1: Huey P. Long Mississippi River Bridge (Pier IVA on Right).

The historic Huey P. Long Mississippi River Bridge in New Orleans, Louisiana is a through truss which will be widened with an additional truss on either side of the existing structure (shown in Figure 1). The foundations for the rehabilitated structure include re-use of the existing caissons plus an additional major pier foundation at Pier IVA.

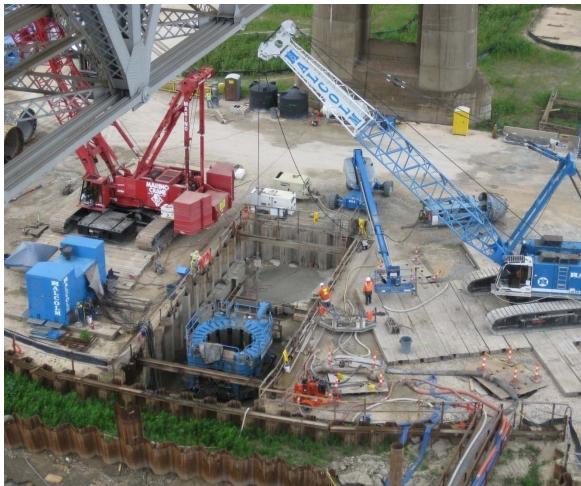
Figure 5: Rotator Placed into Excavation within the Working Platform

The pre-bid specifications contemplated open-hole drilling with mineral slurry, and did not allow for the use of temporary casing for construction of drilled shafts. However, the rotator system with segmental casing was proposed and accepted as a value-engineered alternate approach to the original construction concept. Photos of the construction system are provided in Figures 5 and 6. In this location, the rotator is mounted into the sheet-pile supported excavation, using the excavation support as a reaction system for the equipment.

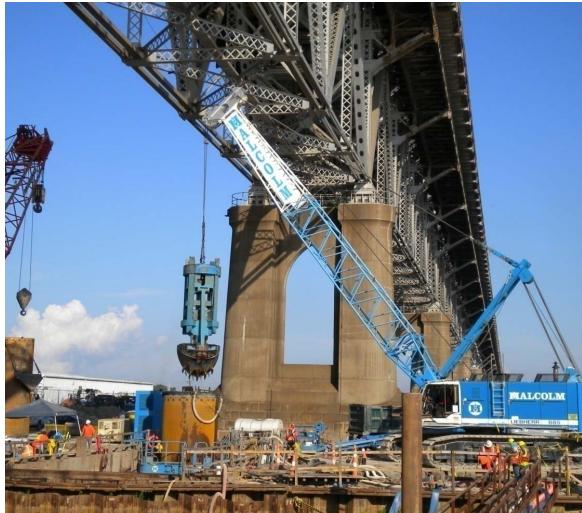
Figure 7: Excavation within the Casing Using a Hammer-grab

- The spoils could be easily handled, as a hammer-grab excavated the soil within the casing as illustrated in Figure 7 and immediately deposited it into a waiting truck to be hauled off-site.
- With a full exchange of the drilling fluid within the casing (dirty fluid was pumped into an adjacent barge), the cased hole minimized the risk of soil inclusions and contamination of the concrete during completion of the shaft.

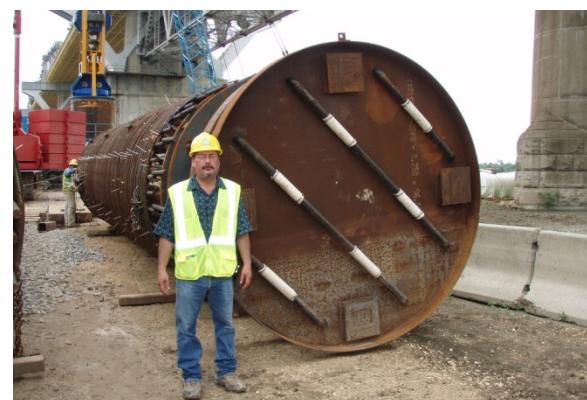
Figure 9: Sleeve-port Base Grouting System

The base-grouting operation was performed after the shaft was completed and crosshole sonic logging (CSL) testing was deemed acceptable. The CSL tubes were used as the plumbing hardware for the grouting operation by connecting pairs of tubes across the base of the reinforcing cage with a sleeve-port system in the connection. This system provided four independent grouting circuits, as illustrated in the photo of Figure 9. A thin metal cover plate was also provided to separate the sleeve-port system from the concrete.

During the grouting operations, each separate grout circuit was pressurized and a careful log maintained of grouting pressure, volume, and measured upward movements of the drilled shaft. The target grout pressure was 650 psi for each shaft, but because these shafts were so deep, grout pressures of up to 800 psi were easily achieved with no significant upward shaft movement. Grout pressure was achieved in each circuit and then released after a period of only a few minutes.

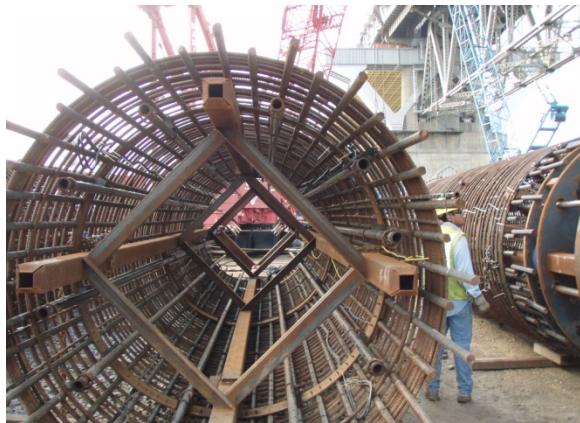
Figure 10: Back-bone Frame for Reinforcing Cage

A key feature of the fabrication and placement of the reinforcement was the use of an internal tubular steel frame to strengthen the cage for self-standing and to provide a guide during splices. This frame, shown in the photo of Figure 10, included circular steel bands which were pre-drilled with holes of u-bolts to provide alignment for each individual bar and CSL tube.

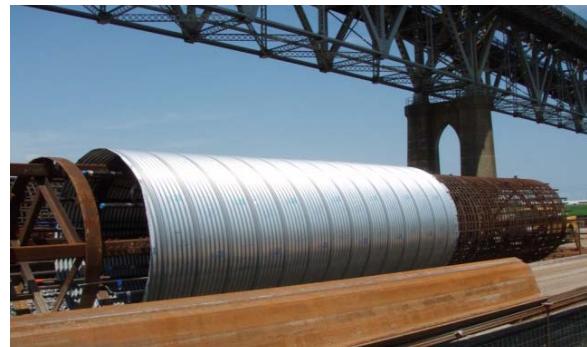
Figure 12: Isolation Casing Attached to Uppermost Section of Reinforcing Cage

The top of each reinforcing cage was fitted with a 25ft length of corrugated metal pipe which was designed to fit inside the rotator casing and act as an isolation casing above the top of the shaft (see photo in Figure 12).

Because the footing was required to be embedded below the river bed, the top of shaft was cut off well below the working platform. The isolation casing contained the reinforcement above top of shaft that would subsequently form the structural connection into the footing after the seal was excavated and completed.

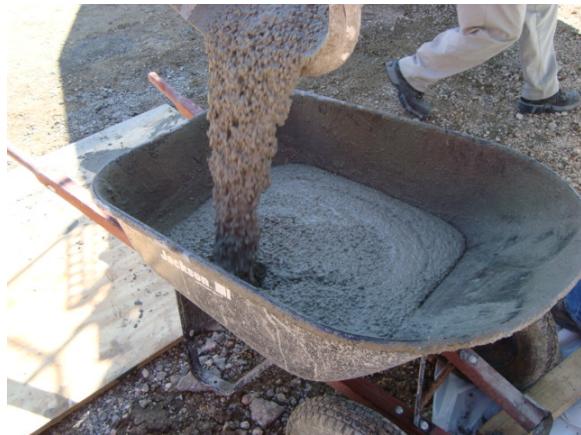
Figure 13: Drilled Shaft Concrete with Good Workability

The concrete mix design was developed with a special emphasis on workability and retention of workability for the duration of the tremie concrete placement operations. This mix, which could be termed a "high-performance" concrete mix based on the performance requirements of the fresh concrete has the characteristics of a self-consolidating concrete (SCC). Some special features of this mix include the following:

A photo of the fresh concrete is provided in Figure 13.
