# Making it sound for Seattle's U-Link

**Richard Hanke, PE, of Malcolm Drilling Company, Phaidra Campbell and Colin Lavassar, PE, of Jacobs Associates, and John Sleavin PE, of Sound Transit, discuss the ground improvement program required for the construction of Seattle's University Link (U-Link) U230 contract, to assist with tunneling operations at multiple locations**

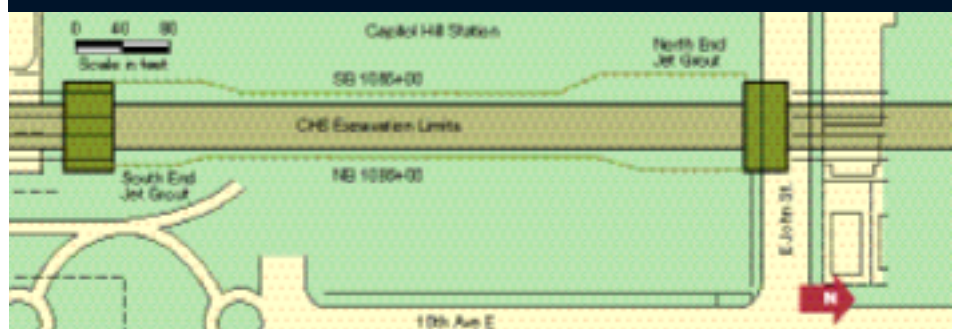
Figure 2: Locations of Jet Grout Zones for the Capitol Hill Station (CHS)

The design considerations of the two jet grout blocks at the CHS were relatively similar. The dimensions of the blocks were calculated based on the anticipated strength of the jet-grout improved soils, the size and length of the TBMs, and the pillar width between the twin tunnels. The blocks were 50ft high, 80ft long and 40ft wide (15m high, 24m long and 12m wide), normal to the tunnel alignment. The dimensions of the blocks provided approximately 20ft (6m) of improved soils above the tunnels and 10ft (3m) below and to the sides. The width was based on assumed TBM lengths of 30ft (9m) and the desire to have at least 10ft (3m) of the final tunnel lining sealed and securely grouted within improved soils before the cutterhead of the TBM breached the safety of the improved zone. A secondary goal of the ground improvement at the CHS was to improve the performance of the excavation support systems to limit shoring displacements (see Figure 2 for the locations of the jet grout zones at the CHS site).

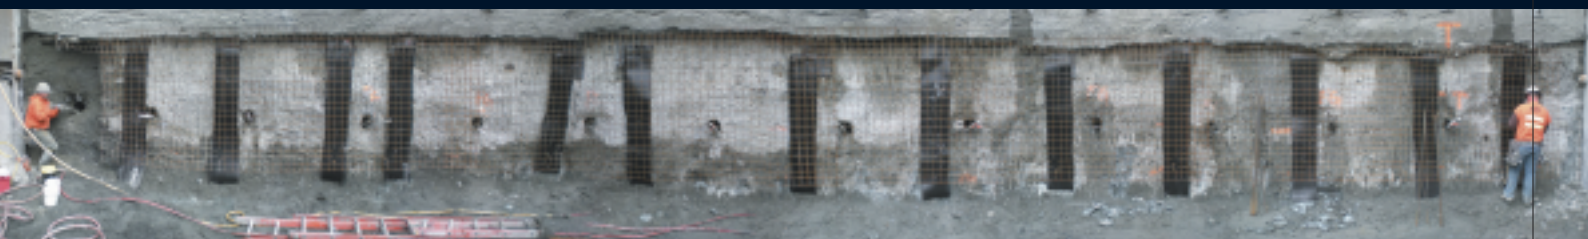
Figure 6: Condition of Jet Grout Face for Lift 5

Excavation of the CHS site began in the middle of July 2010 and was completed in late January 2011. The shoring system for the north wall of the excavation consisted of soil nails with a shotcrete facing. This system was installed in a top-down progression and the south face of the jet grout block was observed as each lift was constructed. A panoramic photograph (Figure 6) was taken to document the condition of the jet grout face for each lift.

The photographs of the exposed face(s) suggest that the jet grouting achieved a relatively uniform level of ground improvement at the south face of the block in the fluvial soils. No pockets or layers of ungrouted soils were observed within the face. A piezometer installed to the north of the jet grout block indicated that the groundwater level was approximately 10ft (3m) above the base of the CHS as it reached the design depth; however, no seepage was observed coming through the face of the block. Some groundwater seepage was noted in the northwest corner of the excavation flowing around the edge of the ground improvement zone.
