# MICROPILE FOUNDATIONS FOR RECONSTRUCTION OF HISTORIC LA LOMA BRIDGE IN PASADENA, CALIFORNIA

Casey Garneau<sup>1</sup>

## ABSTRACT:

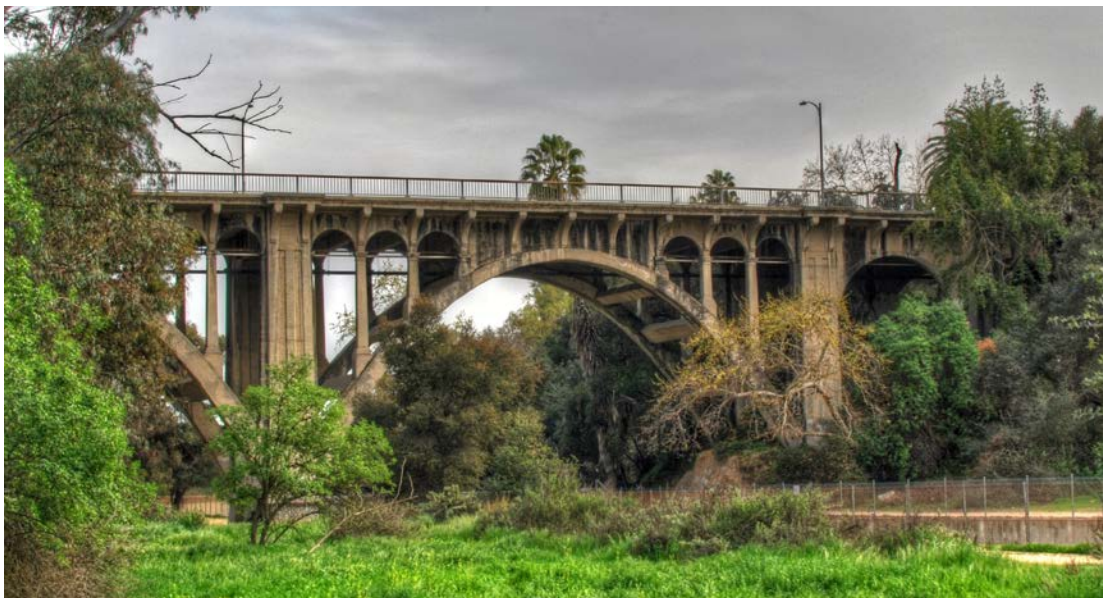
Figure 1 – Original La Loma Bridge

Built just a year after, the La Loma Bridge, pictured in Figure 1, displays similarities of its “big sister”, Pasadena’s famous Colorado Street Bridge, nicknamed “Suicide Bridge”, which spans the Arroyo Seco less than a mile away. While the Colorado Street bridge connected Pasadena to Los Angeles, the La Loma Bridge played a substantial part in Pasadena’s development of the west side of the Arroyo, largely called San Rafael Heights, which was annexed by the City of Pasadena by the completion of this bridge. For several years, the two bridges were the only crossings over the Lower Arroyo and represent the city’s economic and physical need to facilitate automobile traffic over the Arroyo, while also providing impressive picturesque structures for the nearby communities.

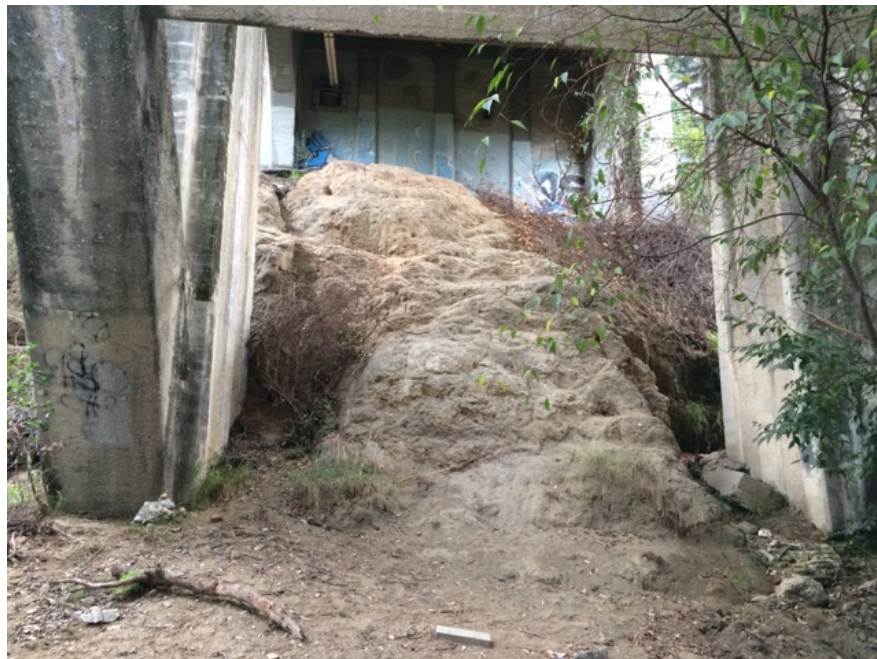
Figure 5 – Pre-construction Conditions at Pier 4 (Quartz Diorite)

The existing bridge spans across the Eagle Rock Fault, which divides the underlying bedrock formations of which the bridge is founded on. On the east side of the fault (Pier 4), the site is underlain with highly weathered and oxidized intrusive quartz diorite rock, while the west side (Pier 2) is underlain with the Topanga Formation, a weathered sandstone conglomerate sedimentary rock.

Various depths of fill and recent alluvium were encountered at the surface at the bottom of the Arroyo Seco canyon consisting of interbedded layers of poorly graded to well graded sand with variable amounts of gravel and abundant cobbles and boulders within the fill layers. The geologic cross-section along the bridge profile is illustrated in Figure 4. All production micropiles were located at areas where the bedrock formations were exposed at the ground surface. Pre-construction photos of existing ground surface are shown in Figure 5 and 6 at Pier 4 (quartz diorite bedrock) and at Pier 2 (Topanga Formation), respectively.

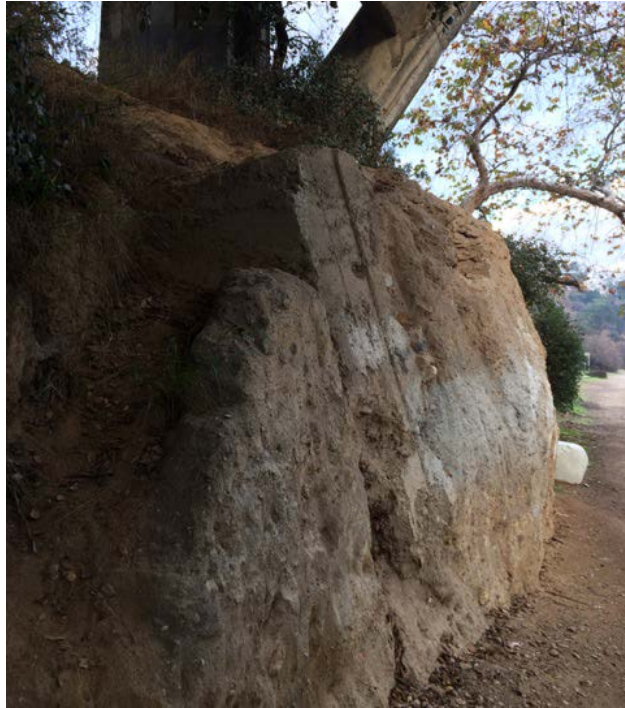
Figure 6 – Pre-construction Conditions at Pier 2 (Topanga Formation)

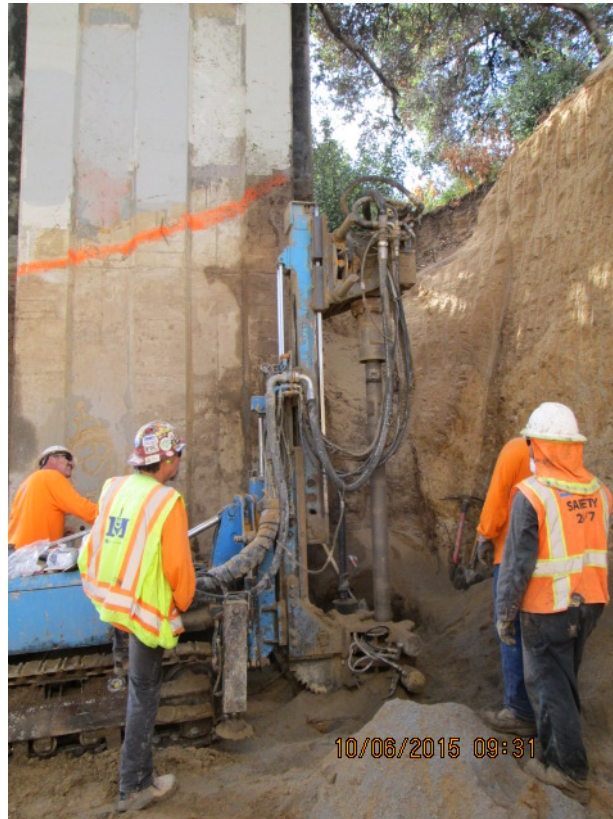
Figure 9 – Micropile Installation

Due to the limited access between the existing bridge pier columns and underneath the existing archways and crossbeams, a small Klemm 702-2 micropile drill rig was utilized to drill and install the micropiles. See Figure 9, which shows the drilling equipment being utilized. The presence of full depth competent bedrock at each pile location required the use of a down-the-hole hammer equipped with a 10” carbide-button hammer bit (see Figure 10). After the shaft was drilled to tip, the reinforcing bar was placed inside the open shaft with plastic centralizers and neat cement grout (water/cement ratio of 0.40 – 0.45) was placed by tremie method into the low end of the shaft. All micropiles were gravity grouted in a single stage for the entire depth of the hole. Post-grouting of the micropiles was not elected due to its limited effectiveness in bedrock type formations. Both the reinforcing center bar and the steel casing were placed at the proper elevation and tied off at the surface using timber and/or angle iron with wire. See Figure 11, which shows the completed micropiles for one of the proposed pier footings.

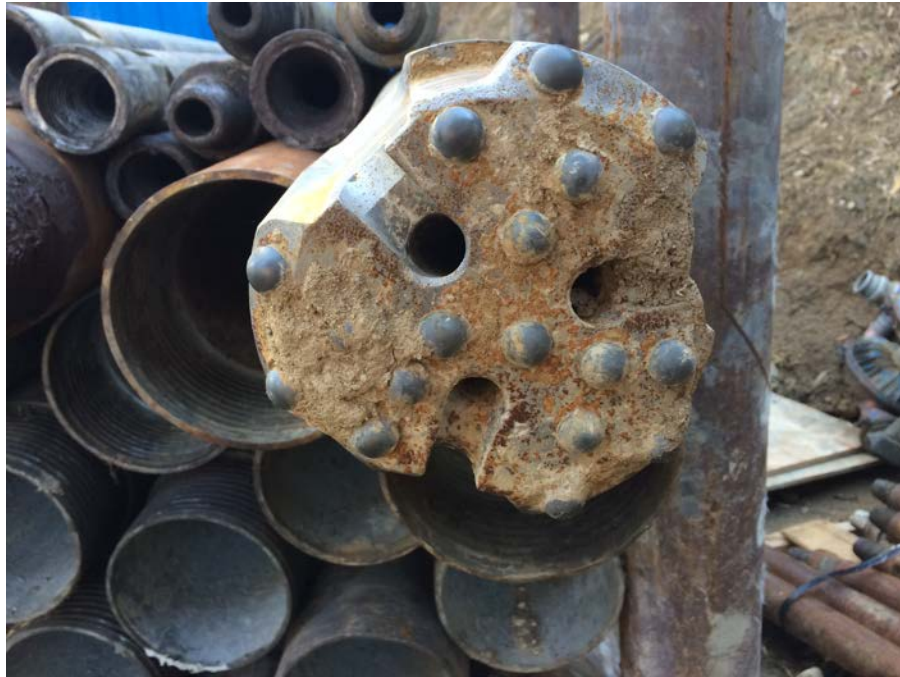
Figure 10 – 10” Hammer Bit

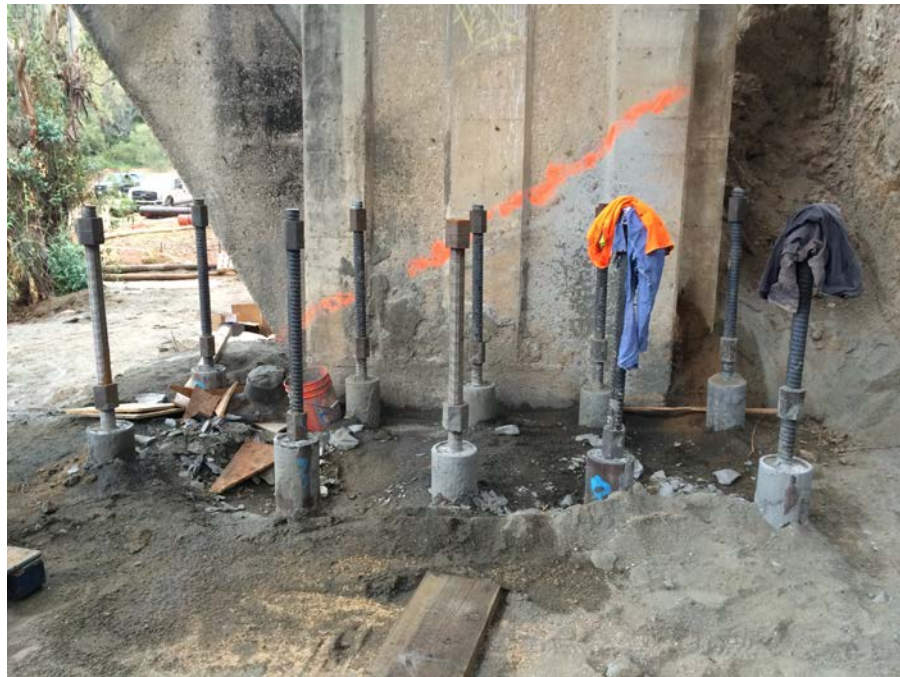
Figure 11 – Completed Micropiles at Pier 2

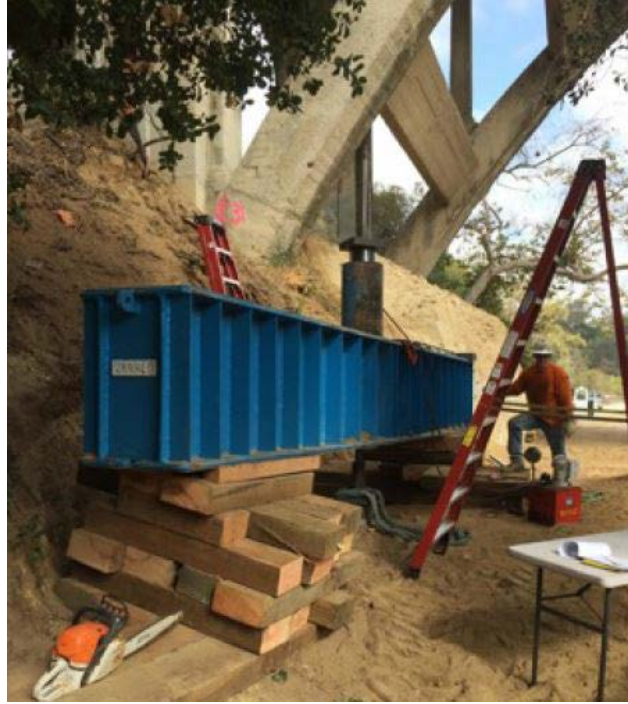
Figure 13 – Pier 2 Verification Test Set-up

micropiles were required to be tested 200% of the design load, for a total of 540 kips. The maximum factored test load was conservatively tested in tension only for both the verification and proof tests to avoid adding additional reaction piles. All micropiles were tested in accordance with ASTM D 3689 as shown in Figure 12, which details the test setup. The tension load was applied to the verification and proof test piles using a reaction system consisting of beams and cribbing. The applied load was measured using a calibrated jack and pressure gauge graduated in 100-psi increments. The micropile movement was measured with two dial displacement indicators capable of measuring to 0.001 inches. A minimum clear distance of 5 times the diameter of the micropile (4'-2") was maintained between the tested pile and the reaction cribbing bearing on competent bedrock material. The sacrificial verification test piles were located near each pier location such that they were installed in representative soil strata for the full depth of the micropile, which was challenging due to the topography of the site and varying layers of fill and recent alluvium located throughout the site. In addition, due to the site constraints and the proposed micropile layout, it was impractical to perform proof testing on many of the production micropiles due to the micropile spacing and proximity to existing bridge column. As such, the proof test locations were pre-selected and limited to only two locations per footing. See Figure 13 for the verification test setup at Pier 2 and Figure 14 for a typical proof test setup.

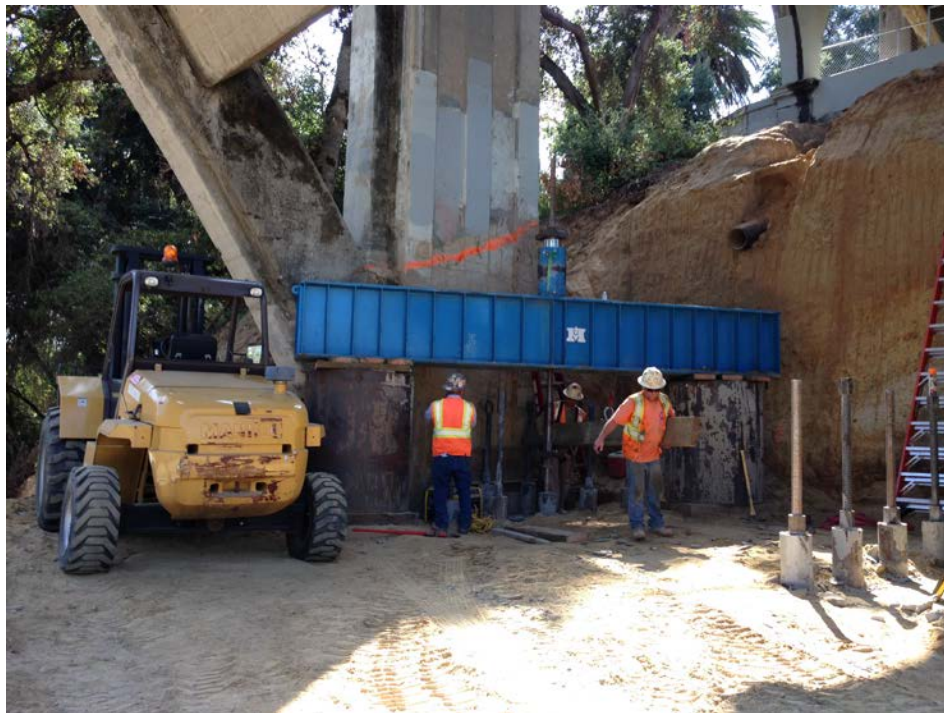
Figure 14 – Proof Test Set-up

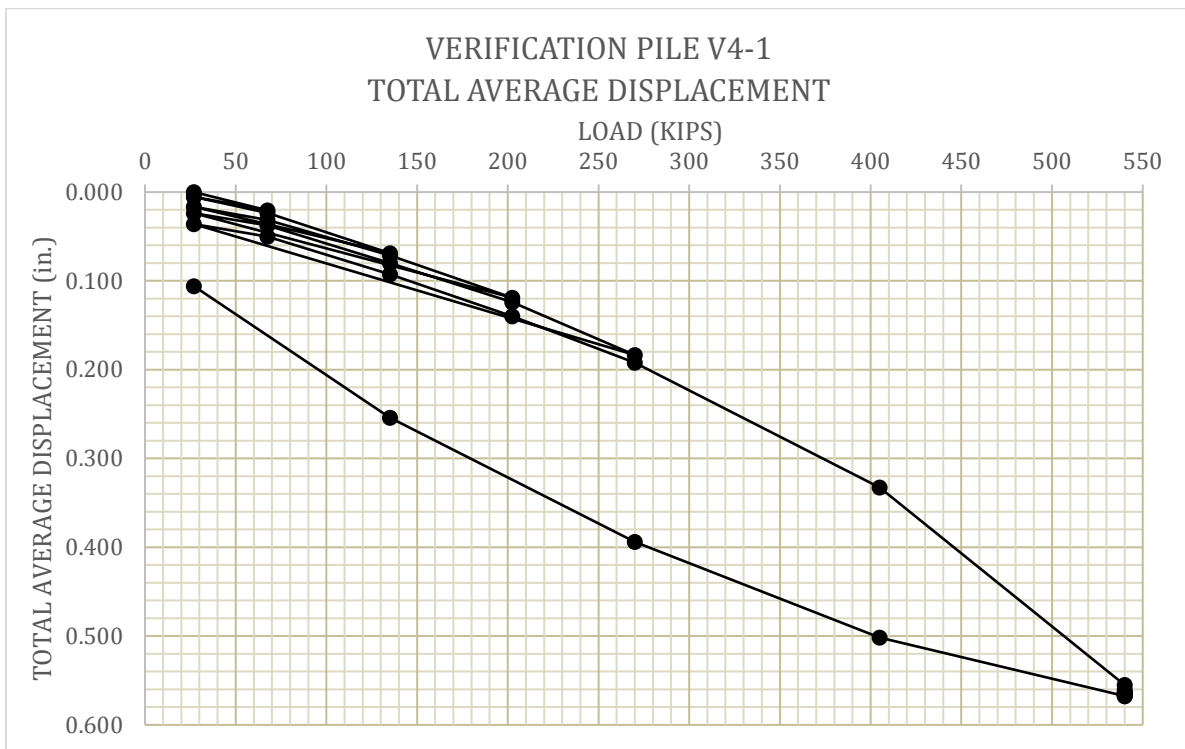
Figure 15 – Displacement Curve for Verification Test at Pier 4

The tension test loads were incrementally loaded and unloaded according to the test schedule shown in the project specifications. The project specifications also established three acceptance criteria for both the verification tests and proof tests. The first criterion was that axial movement at the top of the micropile measured

from the initial alignment load to the first application of 100% of the design load must not exceed 0.5 inch. The second criterion was that the slope of the applied test load versus the top of micropile movement must not exceed 0.025 inch per kip at the maximum test load. The last criterion was that the creep test movement must not exceed 0.04 inch measured from 1 to 10 minutes or 0.08 inch measured from 6 to 60 minutes with the rate of movement being linear or decreasing in time when graphed on a logarithmic scale. The applied load versus top of micropile movement was plotted for all verification and proof tests. Figure 15 shows the pile movement curve for one of the verification test. All verification and proof test micropiles were successfully tested to 200% of the design load and satisfied all acceptance criteria. Both bedrock formations, the intrusive quartz diorite and sandstone conglomerate bedrock, behaved fairly similarly. See Table 1 for a summary of all verification and proof test results.
