COVER FEATURE: MALCOLM DRILLING

# TOEING THE LINE IN THE CROWN OF MAINE

BY JIM GLIDER, PROJECT MANAGER, MALCOLM DRILLING FOUNDATION DRILLING

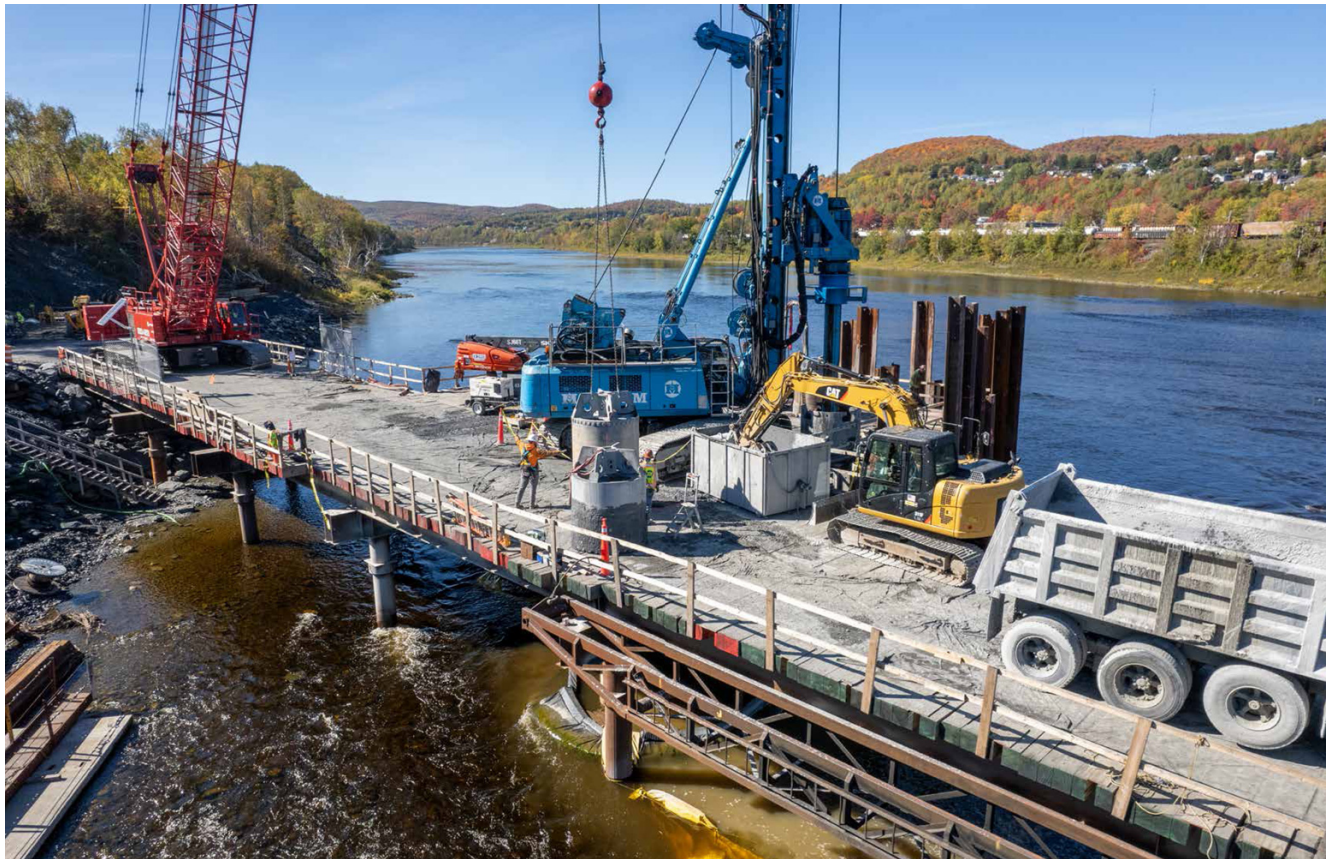
REED & REED ASSISTING MALCOLM DRILLING BY LIFTING AND SETTING THE PERMANENT CASING SECTION FOR MALCOLM'S BG40 TO INSTALL.  
(PHOTO COURTESY OF AROOSTOOK UNMANNED AERIAL PHOTOGRAPHY)

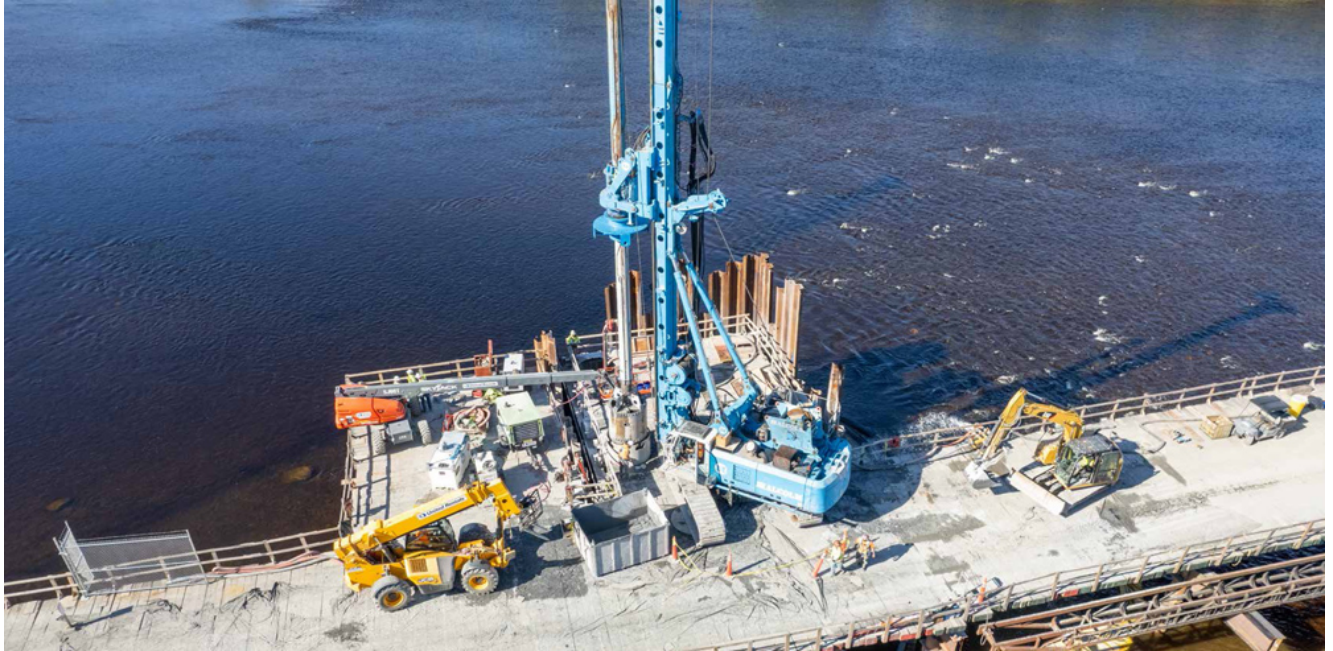
MALCOLM DRILLING INSTALLING DRILLED SHAFTS VIA WORK TRESTLE ON THE ST. JOHN RIVER IN MADAWAKSA, MAINE.

The one that thing that proved to be the most crucial piece to the success of the project was the fact that the elevated work trestle spanned from the US shoreline to the south, all the way to the northernmost pier on the Canadian shoreline, thus encompassing all four of the in-water piers. This access schedule allowed Malcolm to drill Canadian dirt and rock on the eight Canadian drilled shafts, while never actually stepping foot on Canadian soil. Without this trestle set up, all Malcolm crew and equipment would have had to passed through Canadian customs and would have been subject to quarantine regulations.

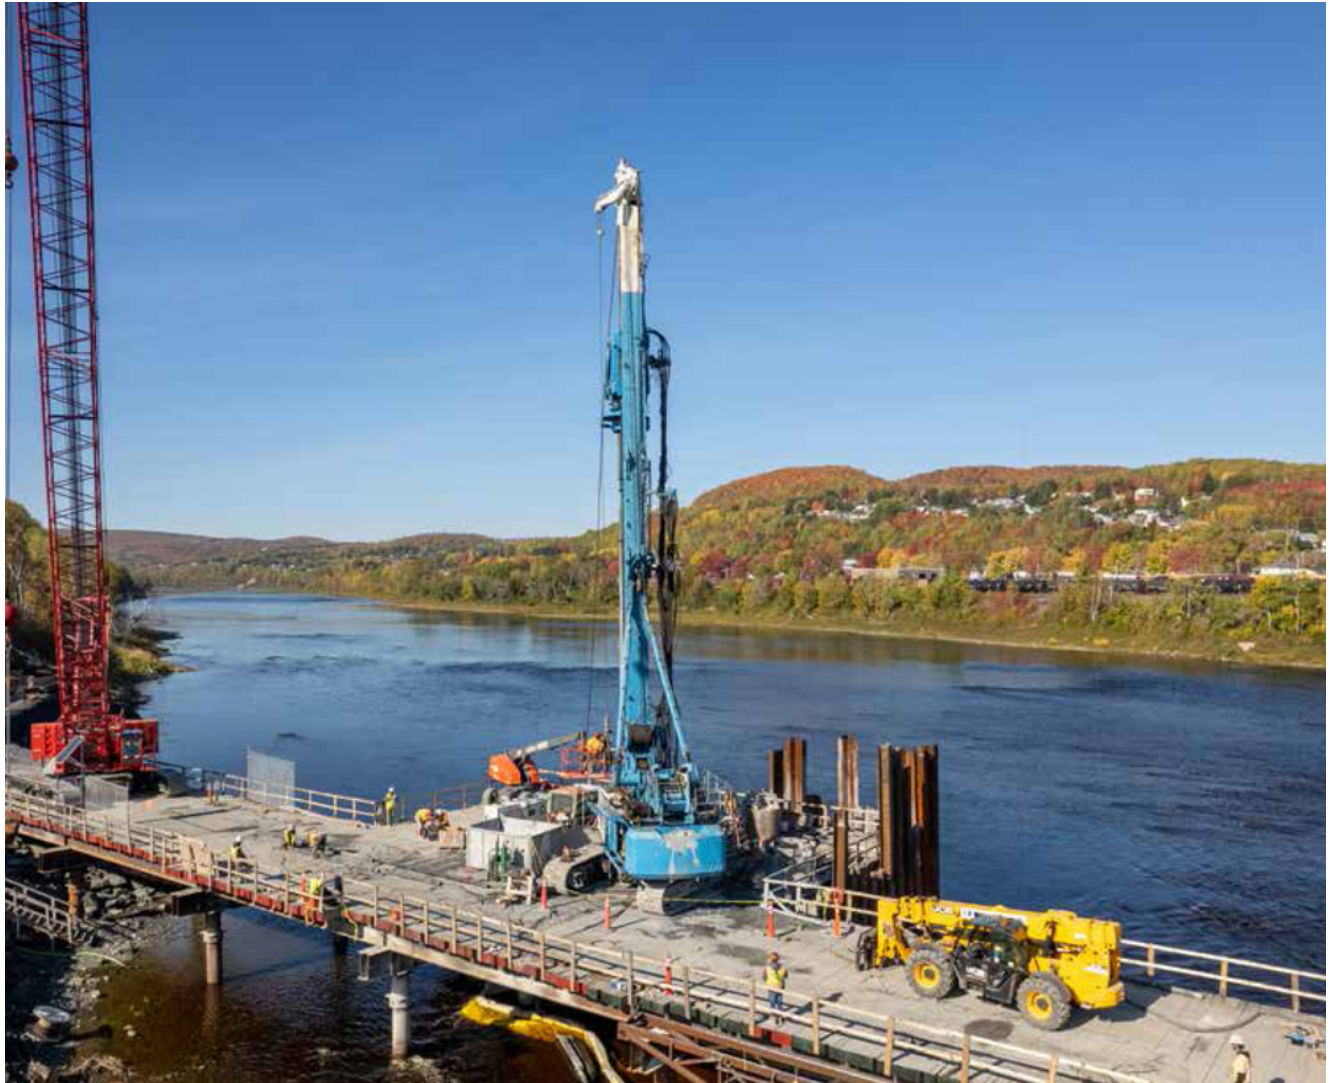
SETTING UP ON THE SHAFT LOCATION. (PHOTO COURTESY OF AROOSTOOK UNMANNED AERIAL PHOTOGRAPHY)

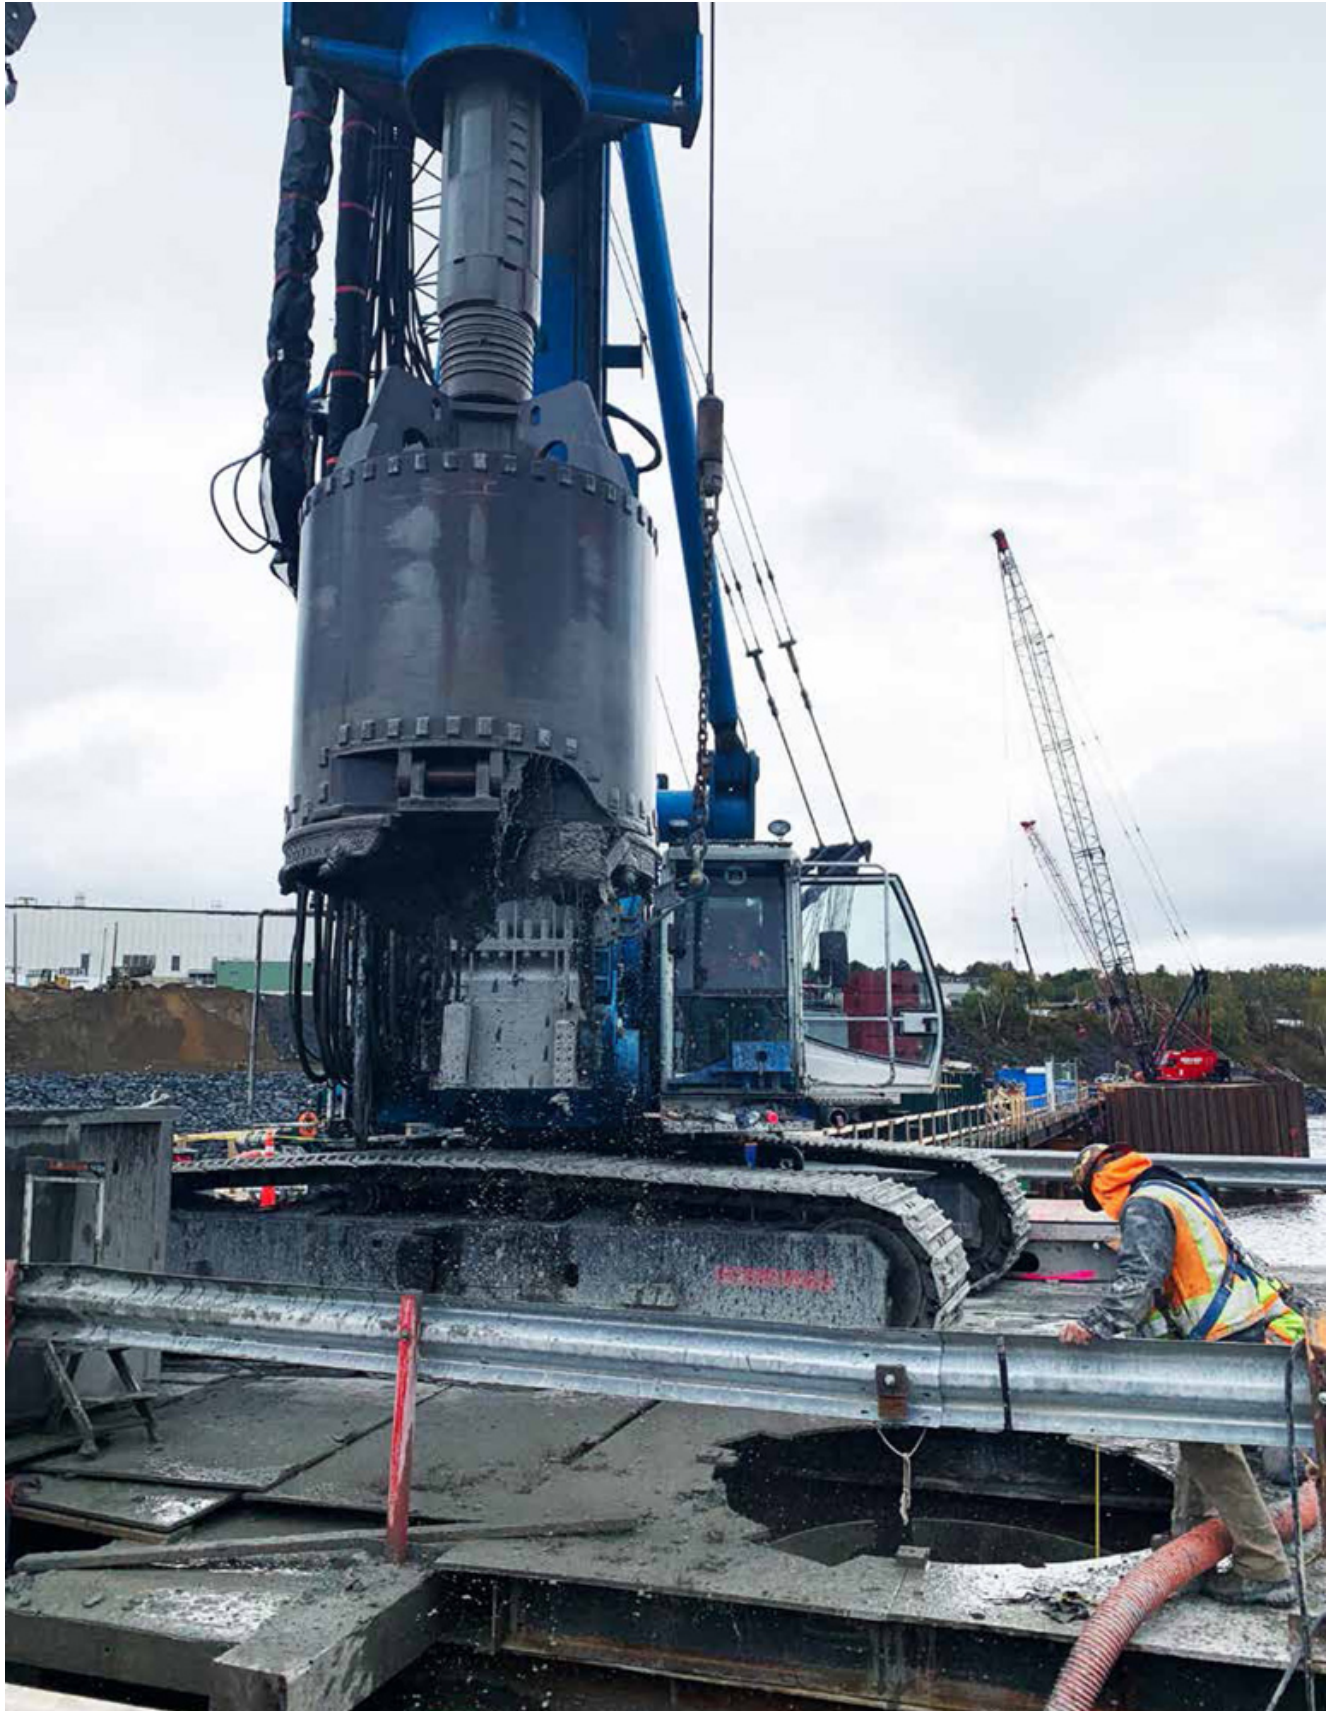
DRILLING SLATE ON THE TRESTLE WORK PLATFORM.

The drilling itself was completed using conventional tooling. The seating of the casing into the fractured slate layers present at the top of the bedrock formation proved to be the biggest challenge on the project. The minimum specified seat of the casing into the bedrock (6 inches) proved to not provide a positive seal against inflowing groundwater. As a result, Malcolm utilized a two-tiered approach to achieve a positive seal. The first step was to advance the casing deeper than required into more competent bedrock below. The second essential change was placing a sacrificial concrete seal at the bottom of the seated casing prior to bedrock drilling.

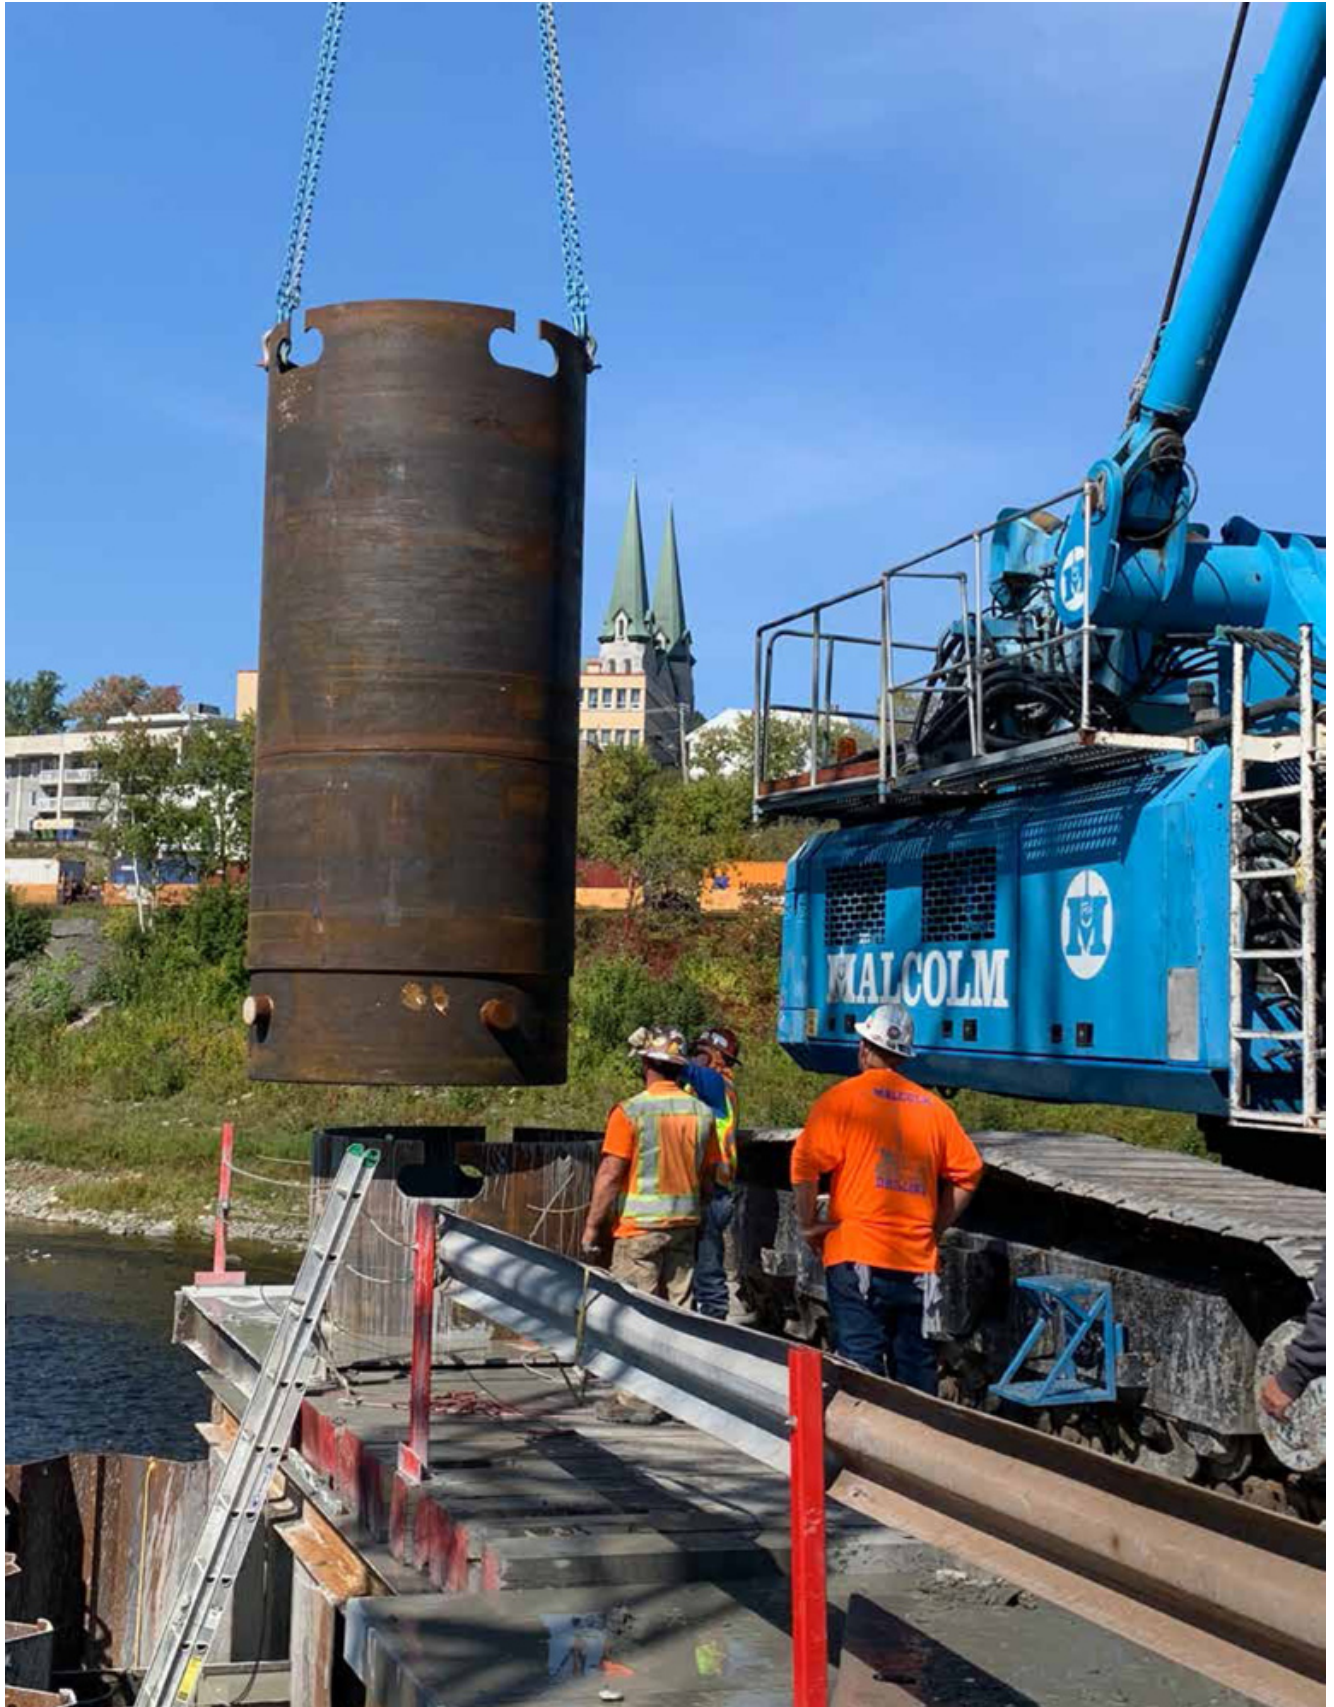
INSTALLING A PERMANENT CASING EXTENSION.

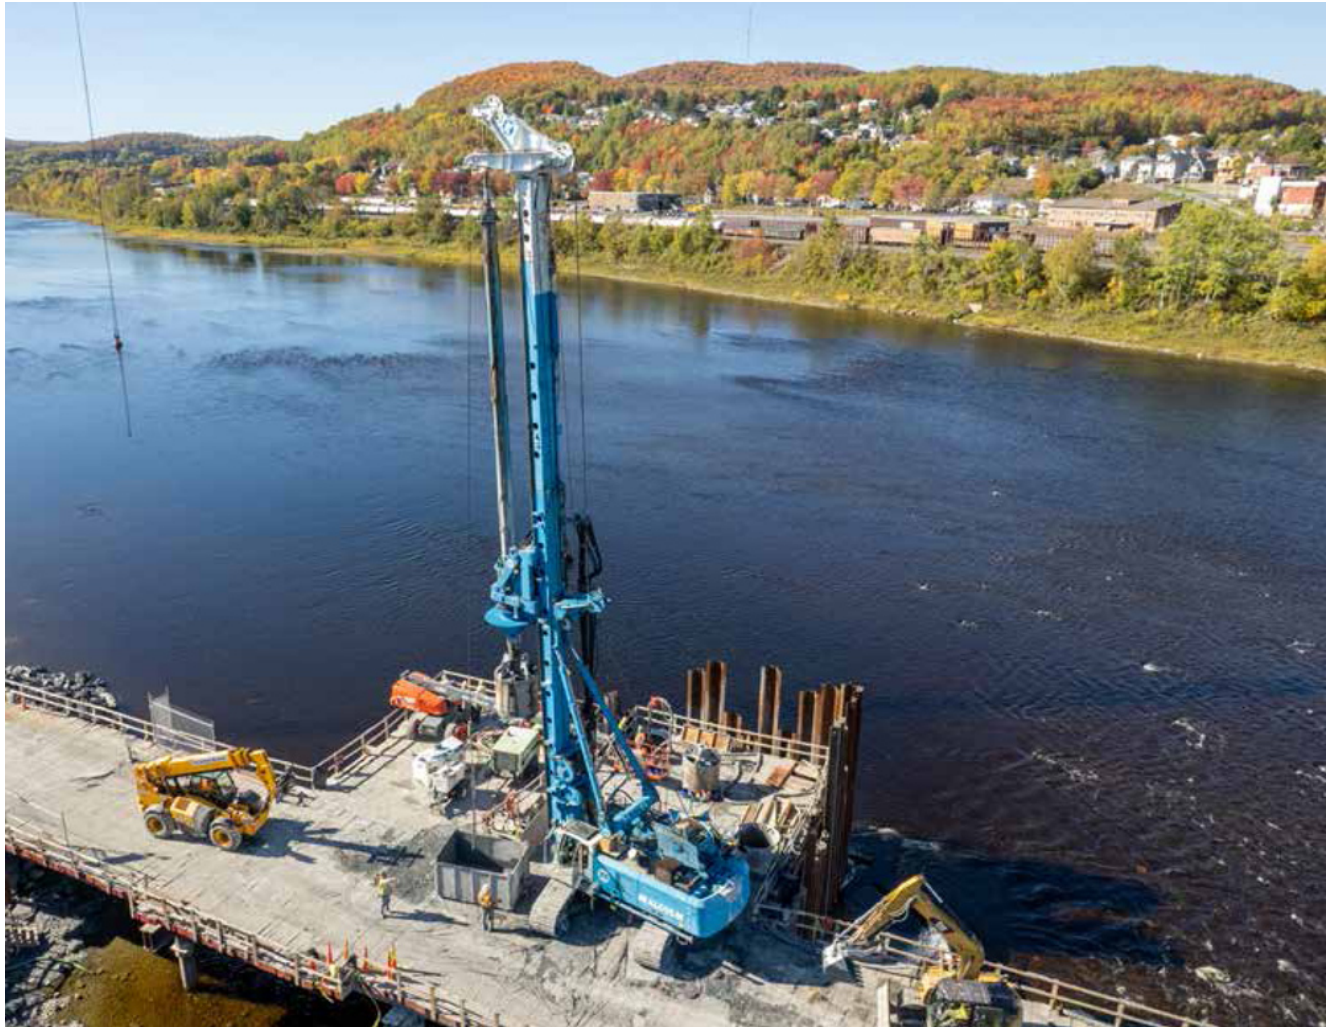
DRILLING OVERBURDEN ON THE TRESTLE WORK PLATFORM. (PHOTO COURTESY OF AROOSTOOK UNMANNED AERIAL PHOTOGRAPHY)

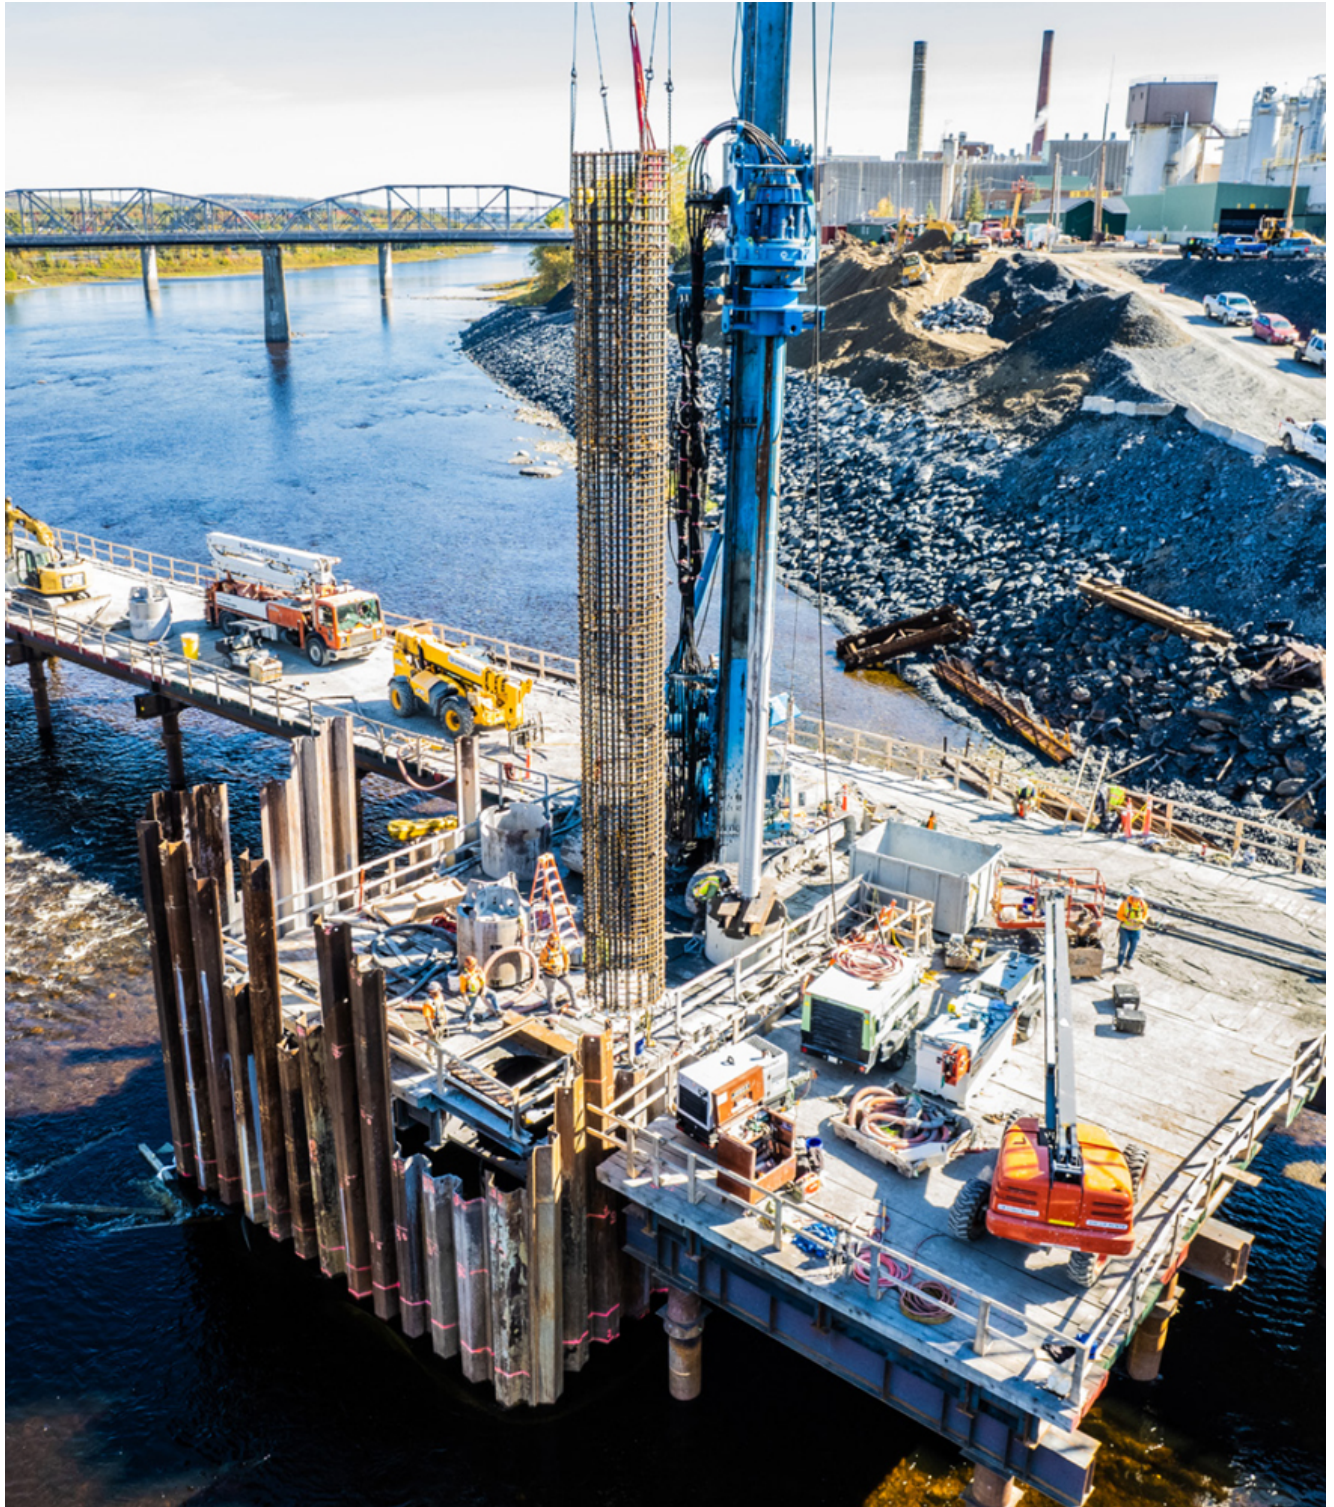
INSTALLING THE REBAR CAGE PRIOR TO CONCRETE PLACEMENT.  
(PHOTO COURTESY OF AROOSTOOK UNMANNED AERIAL PHOTOGRAPHY)

As mentioned, the in-water foundations for this project consisted of 6-foot diameter drilled shafts, permanently cased through the overburden, seated into the bedrock, with a rock socket extending 15 feet below into the bedrock. The Sonic Caliper method was used to measure final shaft verticality and a SQUID device was used to verify base cleanliness prior to concrete placement. TIP wires and CSL tubes were installed in all the shaft rebar cages to perform non-destructive testing following concrete placement and initial cure.
