**CUTTER SOIL MIXED WALL
SHORING AND SEEPAGE CUT OFF
OFFICE BUILDING NEAR WATERFRONT**

John Kvinsland – Malcolm Drilling Company, Kent, Washington
Bob Plum – ASCE, P.E., Principal Kleinfelder Consultants, Seattle

ABSTRACT:

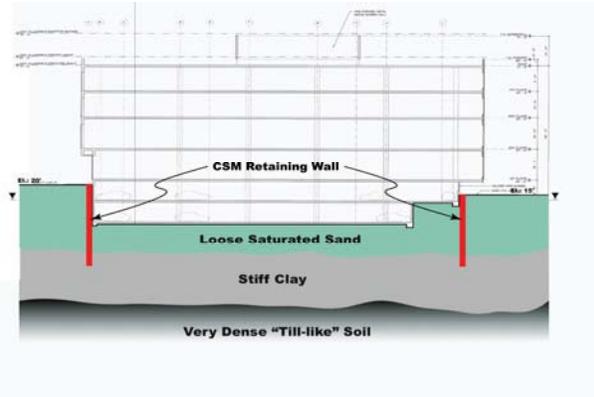
The site is underlain by about 6 to 11 m (20 to 35 feet) of fill and loose beach deposits over a stiff, glacially over-consolidated clay unit as shown on the idealized cross-section in Figure 1. The fill was variable but generally consisted of loose to medium dense silty sands with wood debris. The beach deposits ranged from loose clean sands to loose sandy silt. The underlying stiff clay thickness generally ranges

from about 4.6 to 7.6 m (15 to 25 feet). An older glacial sequence underlies the clay consisting of a very dense till-like deposit and very dense sandy silt overlying a very dense sand and gravel that extended beyond the depth of the borings at about 90 feet. Pre-construction groundwater was measured at an elevation of about 3.7 m (12 feet). Thus, the lowest parking garage

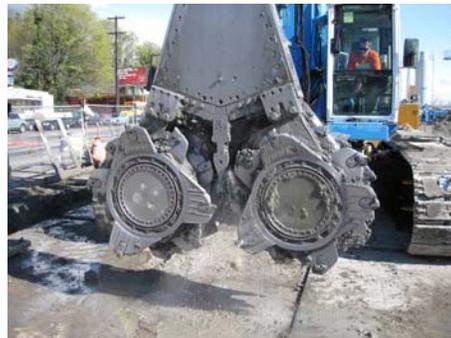
Unlike conventional slurry walls and diaphragm walls that utilize concrete, soil mixing relies on mixing the soils in situ with a cement and bentonite slurry to create a soil-cement wall. Cutter Soil Mixing technology utilizes two sets of vertically mounted cutting wheels rotating about a horizontal axis to produce rectangular panels of treated soil as shown on Figure 2. By overlapping the soil mix panels, a continuous rectangular wall is constructed, as opposed to circular columns created with conventional single-axis or multiple axes deep soil mixing systems. Upon completion of an individual panel, two 460 mm (18 inch) wide flange beams are inserted into the wet “concrete like” soil cement material to provide structural strength to the non-permeable mix. Later, following excavation of the interior of the foundation, tieback anchors can be installed to further increase the shoring capacity of the CSM cutoff wall.

Figure 2. CSM Cutting Head

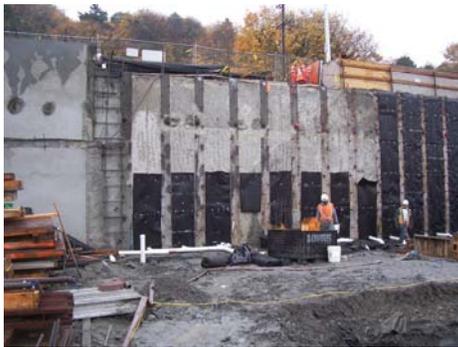
such that the wall functioned as a cantilever wall. On the other sides of the building footprint, the excavations were deeper and one row of tiebacks was installed to provide lateral support. Structurally, the loads were resisted by the steel beams and

Figure 3. Completed CSM Wall

tiebacks with the soilcrete functioning as the lagging. In some areas, the hole drilled through the wall to install the tieback was below the groundwater table. Installing the tiebacks below the water table turned out not to be a significant issue as there was minimal loss of ground and seepage during installation and after installation, the holes were effectively plugged by Non Shrink Grout. In a handful of cases,
