## FEATURE ARTICLE

# Construction of the SR-99 recovery shaft

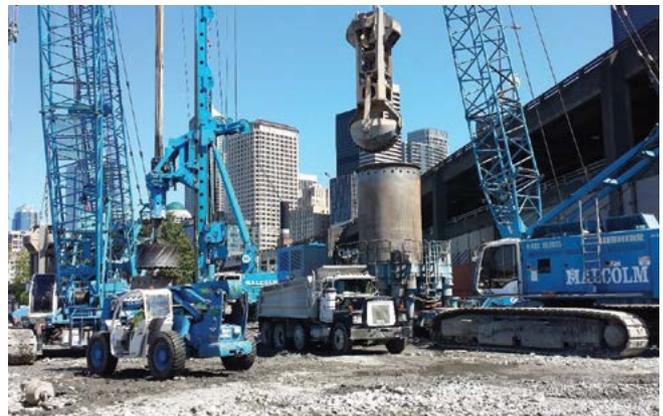
**FIG. 4**

**Access/recovery shaft construction — confined work site.**

in mid-June with Liebherr dig cranes and Leffer oscillators and rotators to start the 2.5 m and 3 m (8.2 ft and 9.11) diameter secant piles included in the final Brierley design (Fig. 2). The work proved to be very difficult due to sequencing and the tight work areas on the job site (Fig. 4). The greatest assets to the project were the two Leffer rotators. These machines proved to be the most efficient at installing the piles on location, maintaining verticality, and with the highest rate of advancement as opposed to just using casing oscillators for advancement. In the end, the shaft work was complete by the end of August 2014, leaving only the remaining grouting and dewatering work to be constructed.

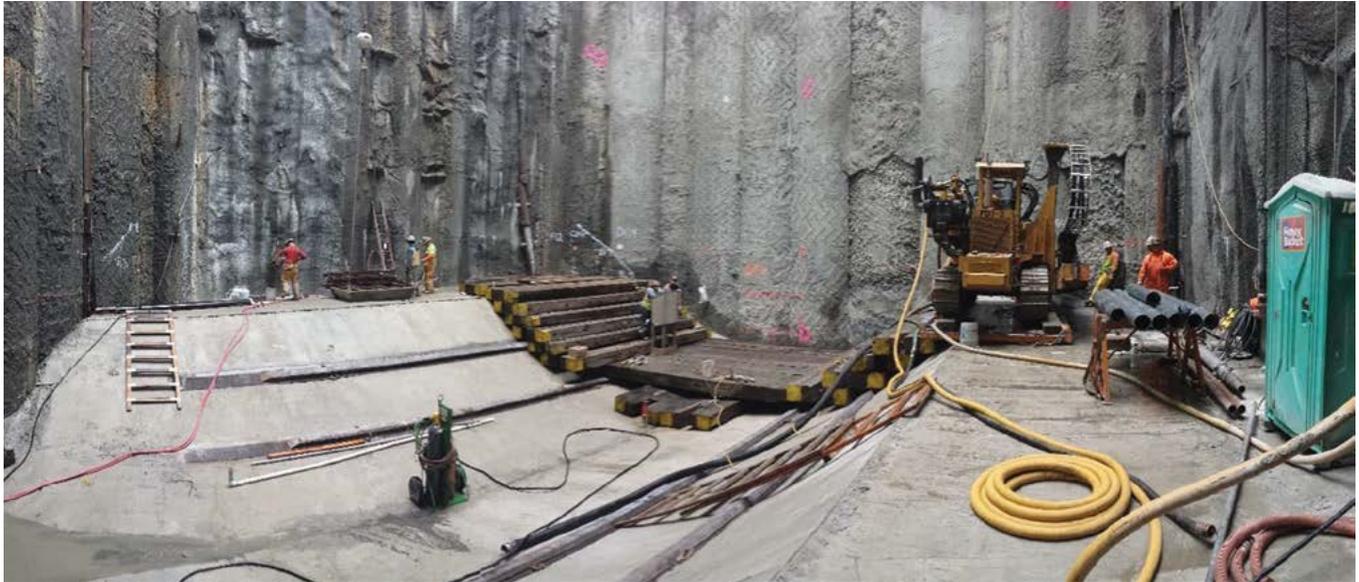
**FIG. 6**

**Access/recovery shaft dewatering – Horizontal drain installation from within shaft.**

Prior to advancing the TBM into the access/recovery shaft, Malcolm was asked to install two horizontal drains, from within the access shaft, to relieve hydrostatic pressure behind the secant pile wall. The 15.25-m (50-ft) long drains were installed working from on top of the upper horizontal surface of the concrete cradle that was constructed in the bottom of the shaft to support Bertha upon entry, (Fig. 6). The horizontal drains were comprised of 7.6 m (24.11 ft) of pre-pack PVC well screen, and 7.6 m (24.11 ft) of solid PVC pipe. The pre-pack well screen consists of a 152 mm (5.9 in.) diameter outer and 51 mm (2 in.) diameter inner slotted PVC well screen with filter sand in the annular space. One drain was located on each side of the TBM, at roughly the lower quarter-points of the tunnel, extending parallel with the alignment (Fig. 5). An approximately 305 mm (12 in.) diameter hole was drilled through the secants and a 254 mm (10 in.) diameter pipe with a blow-out preventer (BOP) was installed at each location. The drains were installed within a 203 mm (8 in.) diameter borehole and equipped with a PVC ball valve to control flow.
