PERFORMANCE OF THREE UNIQUE SHORING SECTIONS FOR BLOCK 75 SHORING

The Block 75 portion of the City Creek redevelopment project in Salt Lake City required multiple shoring walls surrounding the 6 acre site constructed to depths ranging from sixty-five to ninety feet below original street grade. Shoring for the project was challenging due to site soils consisting of cobbles, sands and gravels, interlayered lakebed silty clay and fine sandy silt with incised stream deposits of silty/clayey sand and gravels combined with a high groundwater table. Moreover, several abutting structures each with a unique foundation system would be directly or indirectly supported by the shoring system.

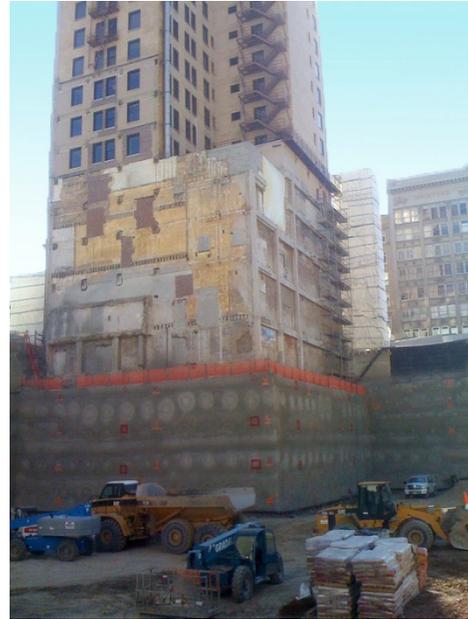
Figure 4: Photo of Shoring at Deseret Trust Building during Excavation

The pre-construction estimate for settlement ranged from ¼ to ½-inch. This estimate (0.05 to 0.1 percent H) was also based upon local experience, using a post-tensioned hybrid shoring system in these conditions. Site instrumentation data showed about 3/8-inch maximum settlement of the building. There were no cracks or other damage observed in the building and the performance of the Deseret Trust shoring "Figure 4" met or exceeded expectations.

All of the soil nails were post-tensioned to approximately 75 percent of their design load, typically 50 to 60 kips. The soldier piles along the east side were extended ten feet deeper to improve global stability to the extent that a tower mat foundation could be excavated 30 feet to the east of the shoring line.
