# Secant Pile Walls

## Mitchell Interchange

### Milwaukee, WI

Retention Systems

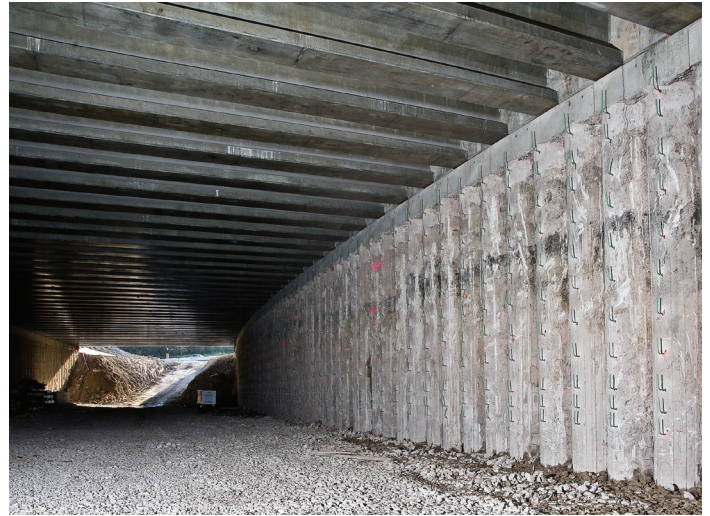
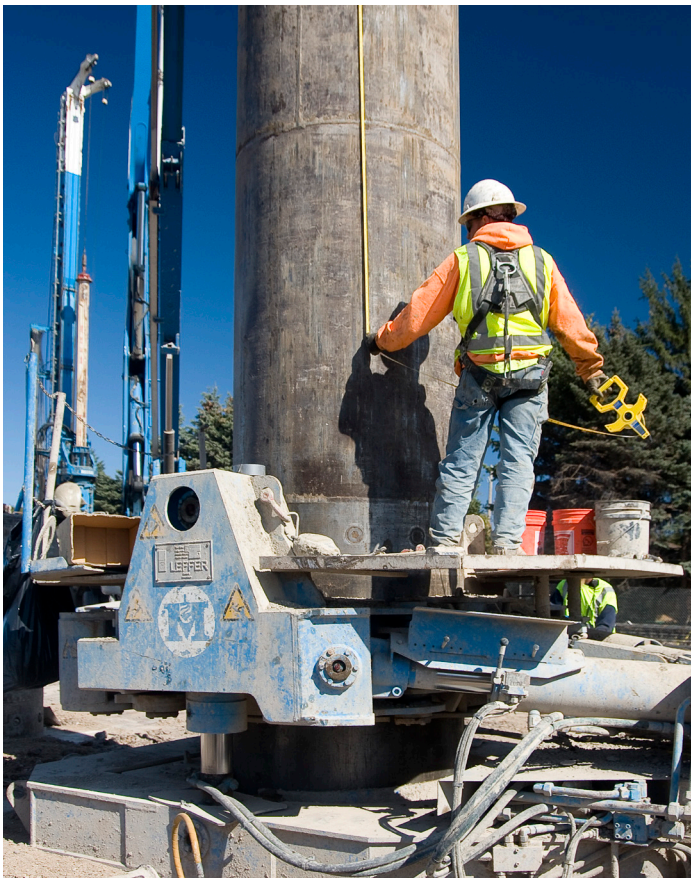
All three tunnel structures consisted of two opposing walls constructed in a top down manner utilizing 4 foot diameter secant piles installed on 3.5 foot spacing. In order to eliminate the requirement for tiebacks, each shaft of the secant pile wall included one reinforcing cage. Rectangular rebar cages were utilized for the “Primary” secant piles to allow enough clearance for the overlapping “Secondary” secant piles which were reinforced with a typical, circular rebar cage. Powerful Bauer BG40 drill rigs were utilized to install sectional drill casing ahead of the shaft excavation ensuring shaft stability. The majority of the secant shafts were installed within close proximity to active freeway traffic and in one location a series of secant piles were constructed below high voltage transmission lines. At this location a casing oscillator was used in conjunction with a LoDril machine (low clearance and extended reach), to accomplish the fully cased secant pile installation.
