CFA PilesOxy Elk Hills Bakersfield, CA

Project Overview

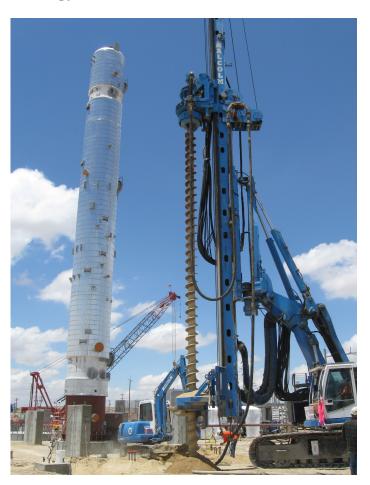
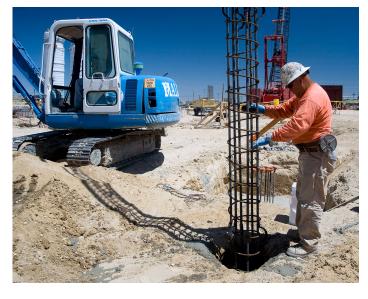
CFA piles are constructed by drilling a continuous flight auger into the ground to desired depth. Grout is then pumped through the auger stem into the hole as the auger is extracted. Reinforcing steel is wet set into the hole before the initial set of the grout. A Bauer RTG 23S equipped with a 65 FT auger was used to install all piles. Drill depths ranged from 20 to 60 FT with an average of 35 FT. Every pile received a rebar cage in lengths of 20 to 25 FT, and in certain areas a full length center bar was added to increase tension capacity of the pile. The project was divided into two phases. The first phase with 430 piles had wide open access with no obstructions and high production rates. For Phase 2 (617 piles) many separate concrete footings had to be constructed, restricting access for many of the piles and pile production decreased accordingly.
