Bridge scour protections bolster flood prevention efforts in Southern California

By Kyle Sansing, Mark Berns, P.E., M.ASCE, and Erin Querio

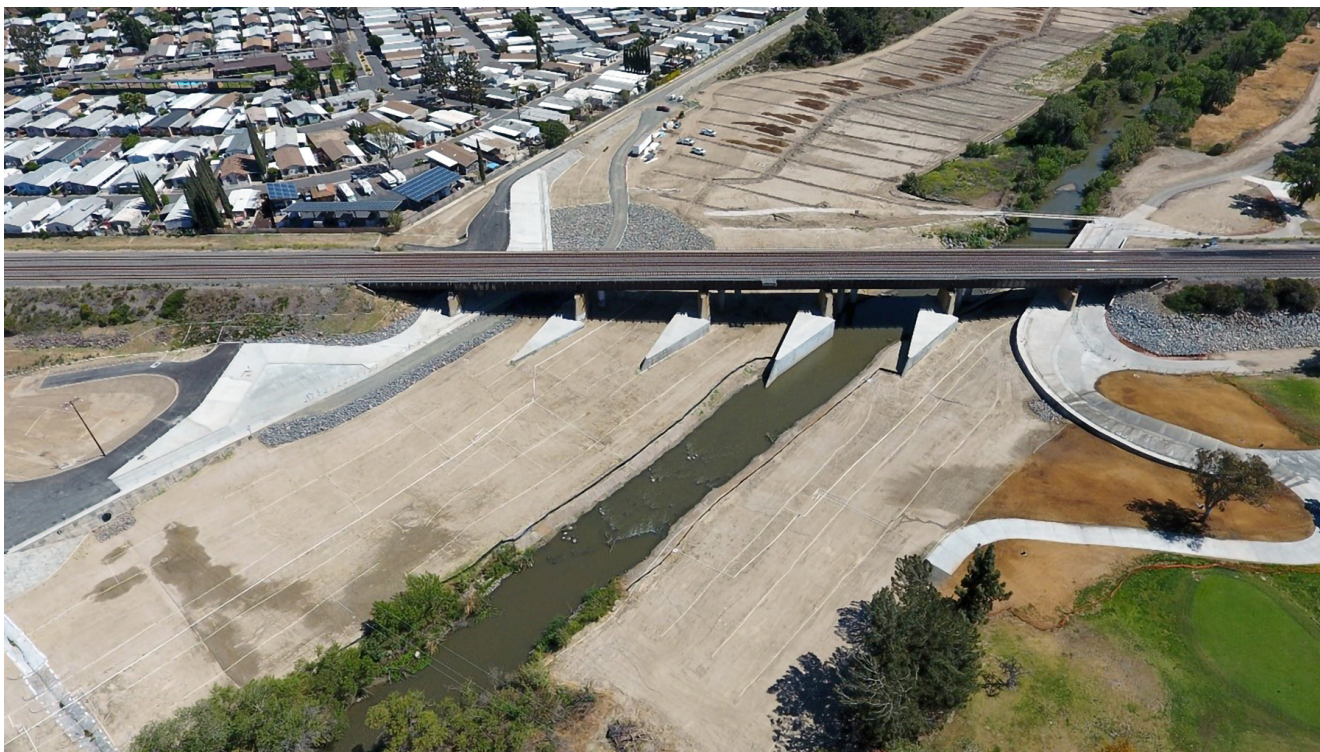
The project involved the construction and installation of scour features that bolster the flood prevention capabilities of the U.S. Army Corps of Engineers in Southern California. (Photograph courtesy of Malcolm International LLC)

The project involved construction of scour features to protect the BNSF Railway bridge that crosses the Santa Ana River and is 2 mi downstream from Prado Dam in Corona, California. These scour protection features were needed primarily to bolster the flood prevention capabilities of the Corps within the region.

The project's primary scour protection work consisted of constructing deep foundation reinforced-concrete diaphragm walls, cast-in-place concrete walls, CIP concrete pier noses founded on driven

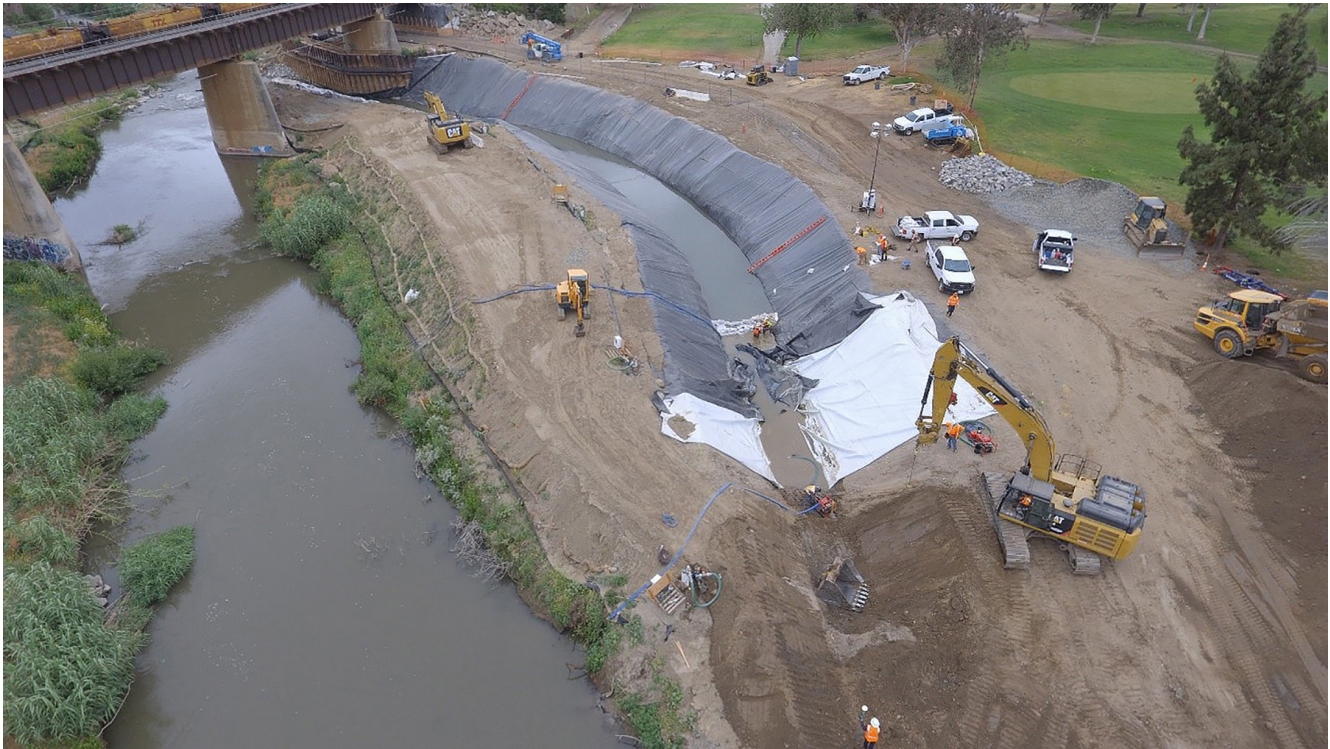
A crew diverted a portion of the Santa Ana River temporarily to accommodate construction of the pier-protection features beneath the bridge. The natural river alignment is on the left. (Photograph courtesy of Malcolm International LLC)

Before construction of the diaphragm walls could commence, about 630 linear ft of the Santa Ana River was temporarily diverted 100 ft to the west to accommodate construction of the pier-protection features beneath the bridge. The diversion, designed by Bittner-Shen Consulting Engineers Inc., was in place for nearly 18 months and had a design capacity of 1,100 cfs.

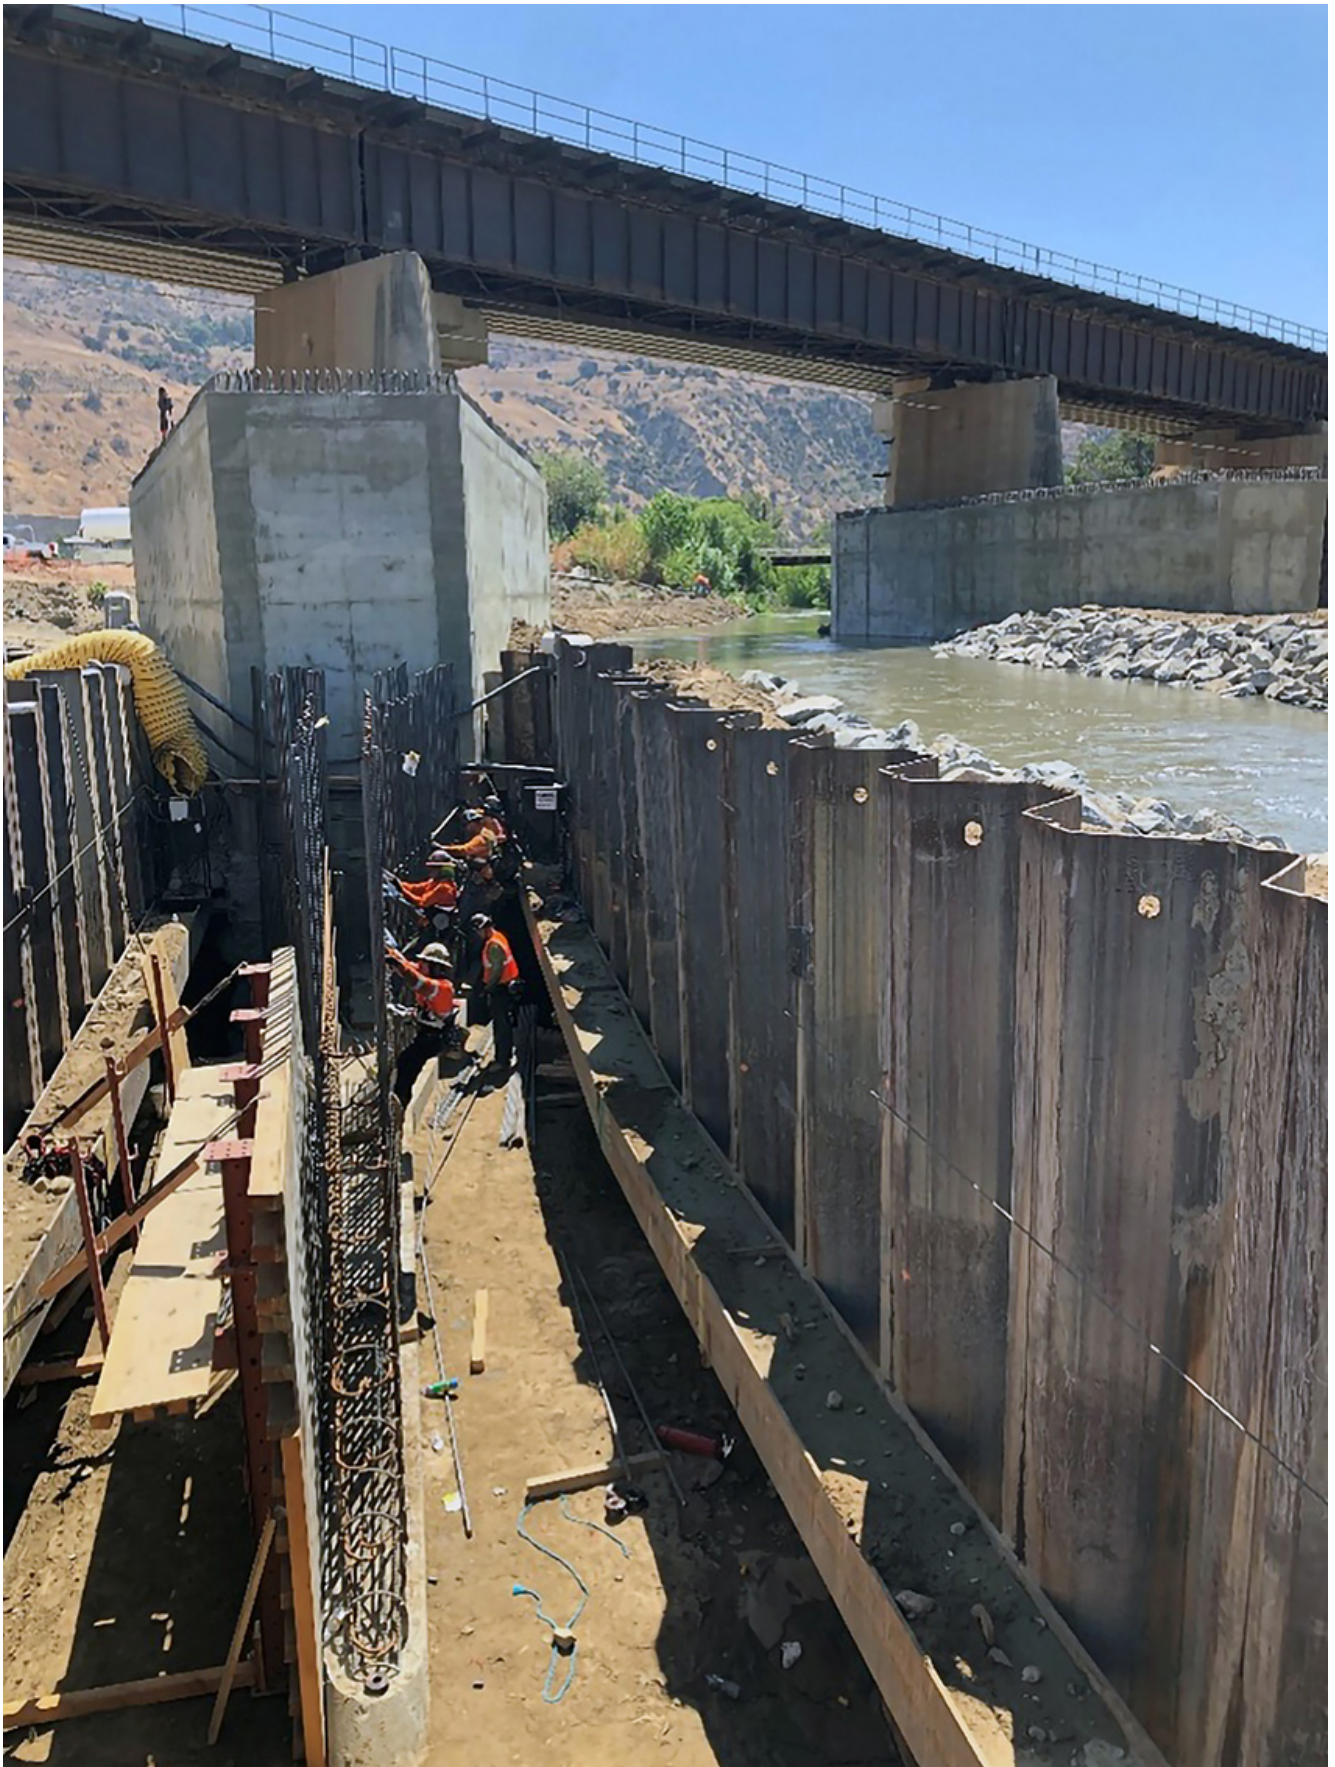
The pier noses, installed inside braced sheet pile cofferdams, feature a tapered shape with rounded edges to allow water to easily pass between pier groups. (Photograph courtesy of Malcolm International LLC)

The training walls placed on the upstream (north) side of the bridge featured a pier nose and tapered shape with a rounded edge to accommodate hydraulic flow and allow water to easily pass between pier groups.

The CIP pier noses and footings were constructed on top of driven steel H-piles. The bottoms of the pier noses were nearly 40 ft below grade. Construction of the pier noses occurred inside braced sheet pile cofferdams, designed by Bittner-Shen. Continuous dewatering wells and localized unwatering were needed for the cofferdams because of the adjacent river and the highly permeable sandy soils in the area.

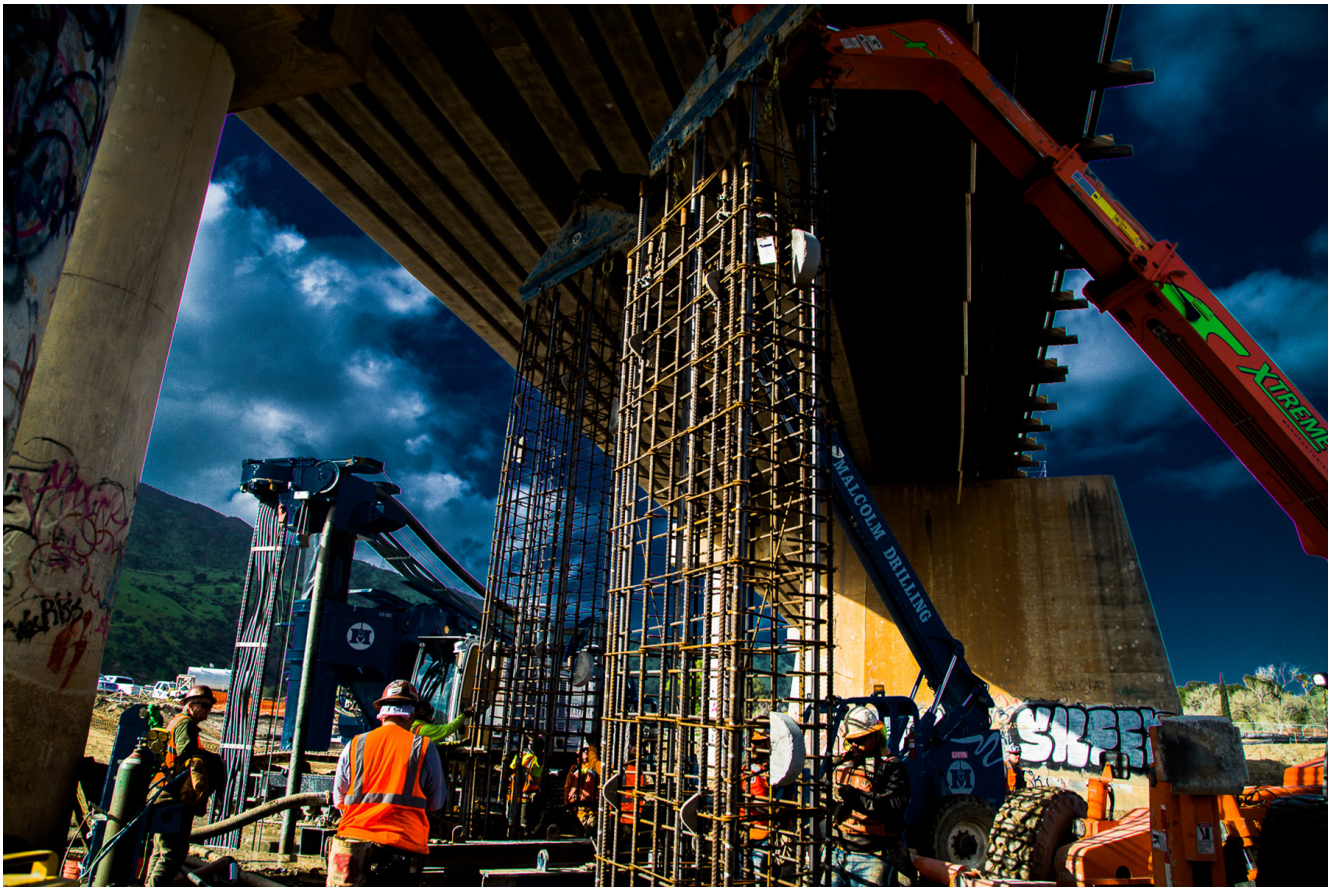
Before the diaphragm wall panels could be installed, panel verticality testing, rebar inspection, and bentonite testing were conducted. (Photograph courtesy of Malcolm International LLC)

In addition to CSL testing, GEI conducted panel verticality testing, concrete testing, rebar inspection, and bentonite slurry testing to meet the acceptance criteria on each panel. Panel verticality testing, rebar inspection, and bentonite testing were required prior to concrete placement. Additionally, GEI carried out CSL testing and concrete strength testing for final panel acceptance.

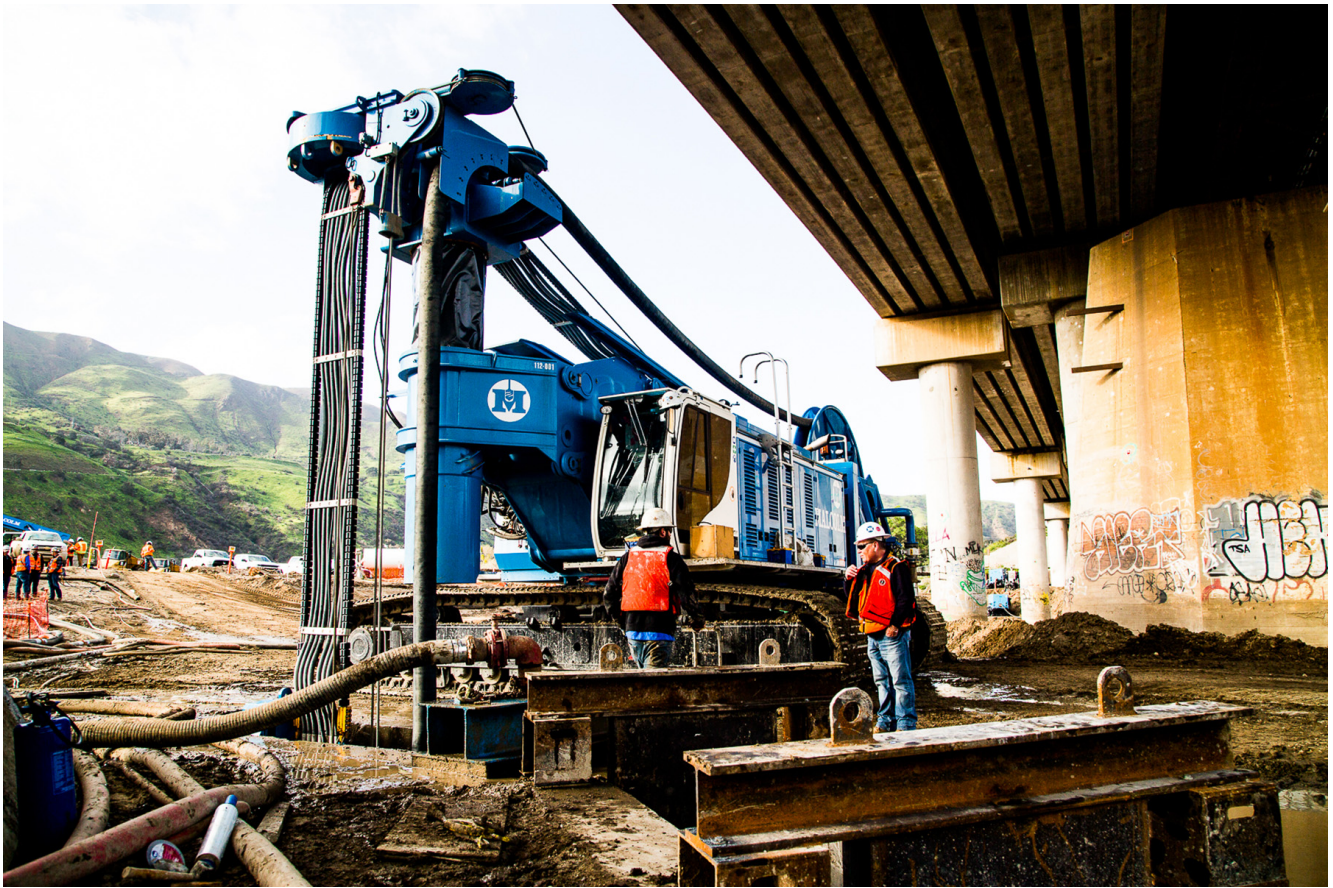
A low-overhead hydro cutter, used to excavate the ground to make room for the diaphragm wall panels, operated within tight tolerances beneath the bridge. (Photograph courtesy of Malcolm International LLC)

MMB and the Corps collaborated to design the individual diaphragm wall panels. Because some of the panels had to be installed beneath the existing bridge structure, a special low-overhead hydro cutter

was used to excavate the ground to make room for the panels.

This same equipment was used for panel excavation outside the bridge structure, but for these panels, the rebar curtains were placed full length without splicing. However, at the time of project bid, there were no low-overhead hydro cutters in North America that could excavate panels of the size indicated in the original design drawings. MMB and the Corps and its design representatives, including AECOM, redesigned the panel sizes so the right equipment could be used for construction of the wall panels.

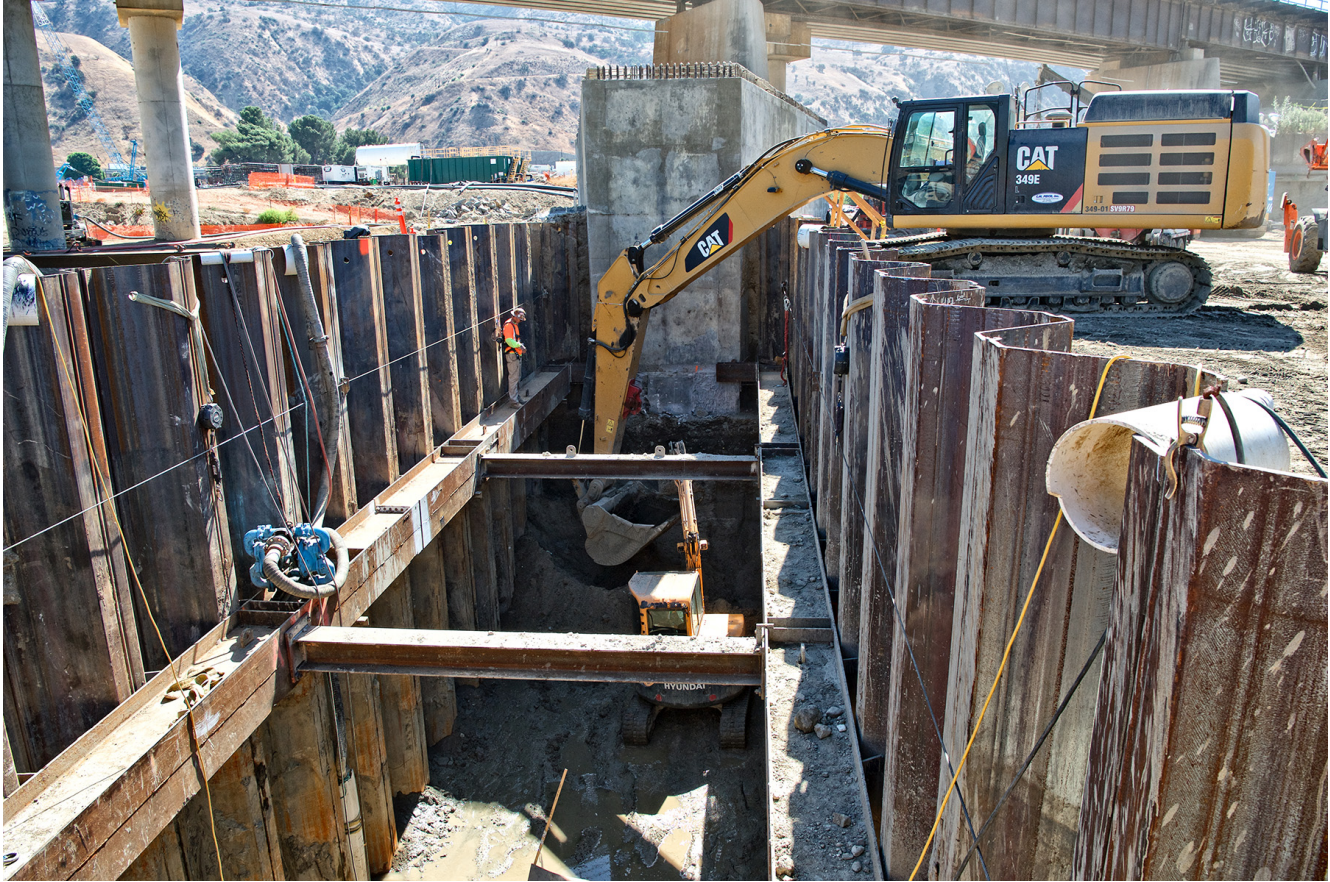
Excavation inside the cofferdams entailed the use of dewatering wells and localized unwatering due to the adjacent river and the highly permeable sandy soils at the site. (Photograph courtesy of Malcolm International LLC)

Diaphragm wall construction, temporary river diversion, and excavation activities for grouted and derrick stone placements all required dewatering of the surrounding site soils. The dewatering system was designed by Middour Consulting LLC. In total, 63 dewatering wells and 11 observation wells were needed to accommodate construction activities. Ten of the dewatering wells were 4 in. in diameter and the remaining ones were 12 in. in diameter. Water captured from the dewatering wells was piped to nearby holding tanks to test its quality and allow sediments to settle before being discharged into the adjacent river.

Combined dewatering discharge flows were generally around 3,000 gpm, with maximum flows near 6,000 gpm, due in large part to the pervious, sandy soils found throughout the project and the close proximity of the Santa Ana River.

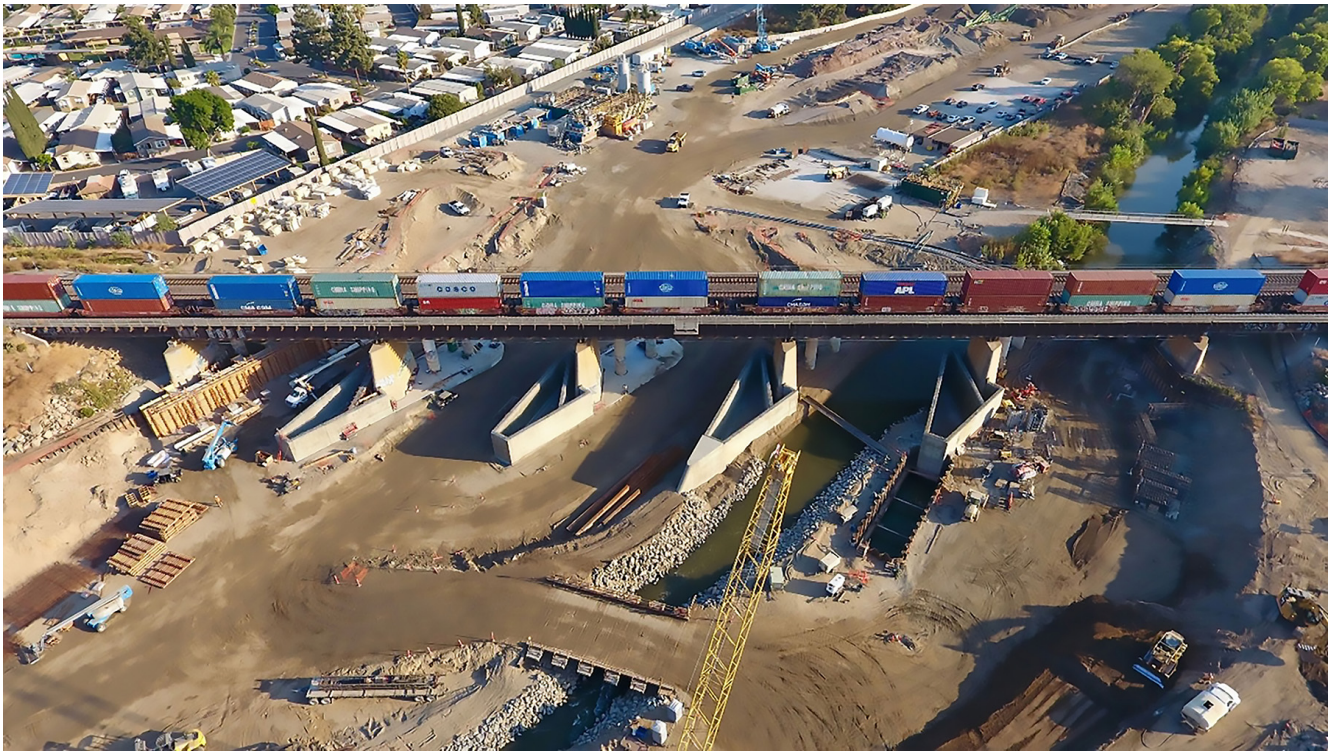
Careful coordination was needed to ensure that train traffic did not stop at any time during construction. (Photograph courtesy of Malcolm International LLC)

This complex project had many stakeholders, the most critical being BNSF Railway, whose tracks ran through the center of the project. The tracks carry more than 100 trains per day, and train traffic could not be stopped at any time during construction. A BNSF flagger was on-site and maintained radio communications with all oncoming trains during the entirety of diaphragm wall construction and other work operations. Reduced train speeds were sometimes required, and some construction operations classified as high risk by BNSF were temporarily delayed when trains were approaching and passing through the project limits.
